RE: Drinking Water Sampling – Antonia Middle School
6798 St. Lukes Church Road, Barnhart, MO 63012
Project Number: 923294

Drinking Water Assessment
 Antonia Middle School
 Fox C-6 School District

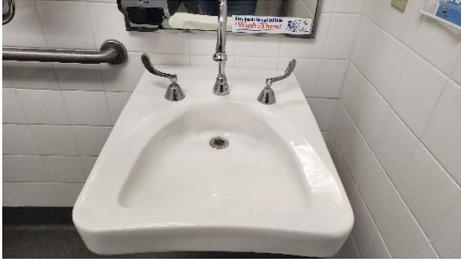
ID:	294-AMS-01	Location:	Kitchen Restroom		
Photo:

Manufacturer:	Chicago Faucet Co.		
		Description:			
		Handwashing Sink			
		Result:	21	ppb	
		Date Sampled:	3/28/2024	By:	JH
Recommended Action:		Mark as Non-Potable/Not for drinking water

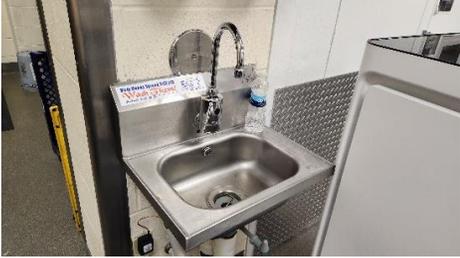
ID:	294-AMS-02	Location:	Kitchen		
Photo:

Manufacturer:	Chicago Faucet Co.		
		Description:			
		Handwashing Sink			
		Result:	<1.0	ppb	
		Date Sampled:	3/28/2024	By:	JH
Recommended Action:

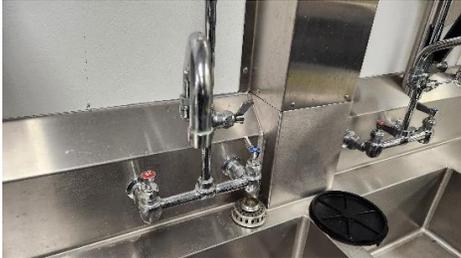
ID:	294-AMS-03	Location:	Kitchen		
Photo:

Manufacturer:	Chicago Faucet Co.		
		Description:			
		Left sink			
		Result:	2.7	ppb	
		Date Sampled:	3/28/2024	By:	JH
Recommended Action:

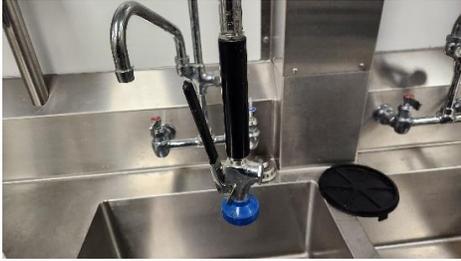
ID:	294-AMS-04	Location:	Kitchen	
Photo:

Manufacturer:	Fisher	
		Description:		
		Left Dish sprayer		
		Result:	2.6	ppb
Recommended Action:		Date Sampled:	3/28/2024	By: JH

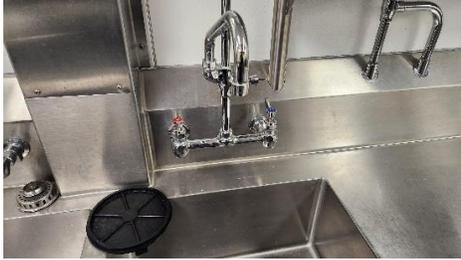
ID:	294-AMS-05	Location:	Kitchen	
Photo:

Manufacturer:	Chicago Faucet Co.	
		Description:		
		Right sink		
		Result:	20.1	ppb
Recommended Action:		Date Sampled:	3/28/2024	By: JH

In accordance with the requirements set forth in Missouri Bill 681/662, fixtures exhibiting lead concentrations above 5 ppb must be remediated by replacement of lead-containing pipes, solder, fittings or fixtures with lead-free components, or the school shall install filtration at each point where water enters the building until such time as the source can be remediated. If installing a filter is not feasible, the school shall provide purified water at each outlet inventoried.

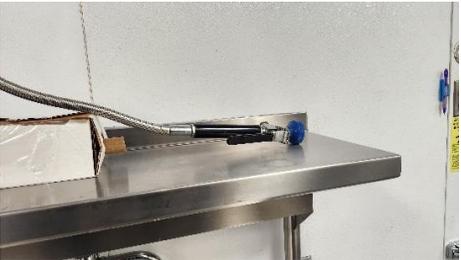
ID:	294-AMS-06	Location:	Kitchen	
Photo:

Manufacturer:	Fisher	
		Description:		
		Right dish sprayer		
		Result:	26.2	ppb
Recommended Action:		Date Sampled:	3/28/2024	By: JH

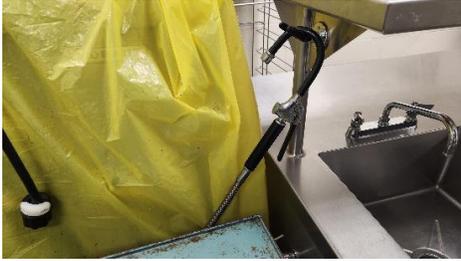
ID:	294-AMS-07	Location:	Kitchen	
Photo:

Manufacturer:	Unknown	
		Description:		
		Prep Table pot filler		
		Lab error.		
		Result:	NA	ppb
Date Sampled:	3/28/2024	By:	JH	
Recommended Action:		Remove from Service/Sample Source

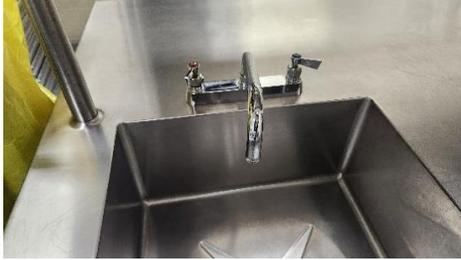
ID:	294-AMS-08	Location:	Kitchen		
Photo:

Manufacturer:	Unknown		
		Description:			
		Prep table sink			
		Result:	3	ppb	
		Date Sampled:	3/28/2024	By:	JH
Recommended Action:

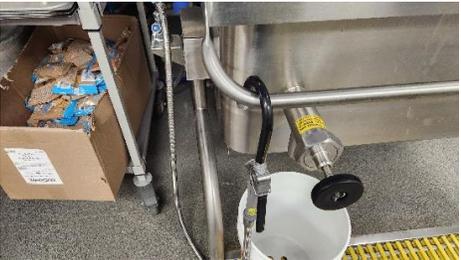
ID:	294-AMS-09	Location:	Kitchen		
Photo:

Manufacturer:	Unknown		
		Description:			
		Skillet Pot filler			
		Result:	2.3	ppb	
		Date Sampled:	3/28/2024	By:	JH
Recommended Action:

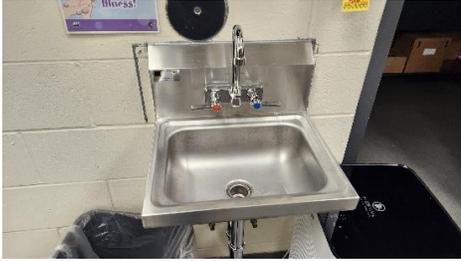
ID:	294-AMS-10	Location:	Kitchen	
Photo:

Manufacturer:	Elkay	
		Description:		
		Handwashing Sink		
		Result:	4.1	ppb
		Date Sampled:	3/28/2024	By: JH
Recommended Action:

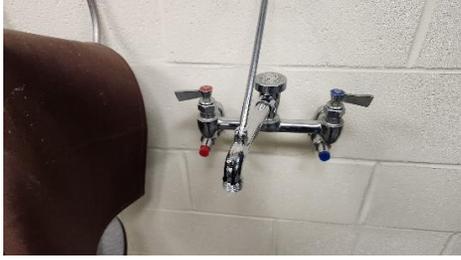
ID:	294-AMS-11	Location:	Kitchen Dish Area	
Photo:

Manufacturer:	Watts	
		Description:		
		Hose Bib		
		Lab error.		
		Result:	NA	ppb
Date Sampled:	3/28/2024	By: JH		
Recommended Action:		Remove from Service/Sample Source

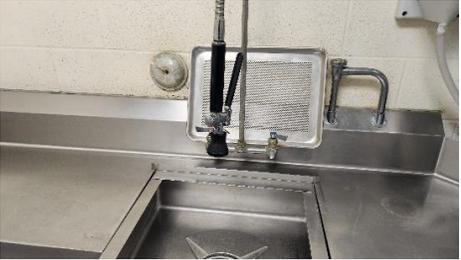
ID:	294-AMS-12	Location:	Kitchen Dish Area	
Photo:

Manufacturer:	Unknown	
		Description:		
		Dish Sprayer		
		Result:	<1.0	ppb
		Date Sampled:	3/28/2024	By: JH
Recommended Action:

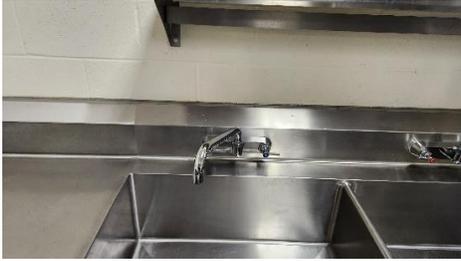
ID:	294-AMS-13	Location:	Kitchen Dish Area		
Photo:

Manufacturer:	Unknown		
		Description:			
		Left Sink			
		Result:	10	ppb	
		Date Sampled:	3/28/2024	By:	JH
Recommended Action:		Replace Fixture/Unit and Resample

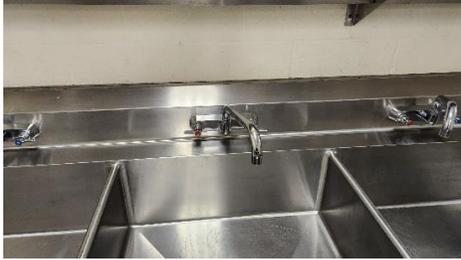
ID:	294-AMS-14	Location:	Kitchen Dish Area		
Photo:

Manufacturer:	Unknown		
		Description:			
		Center Sink			
		Result:	7.9	ppb	
		Date Sampled:	3/28/2024	By:	JH
Recommended Action:		Replace Fixture/Unit and Resample

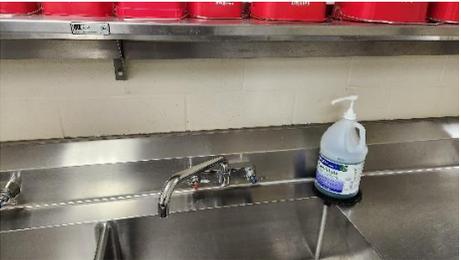
ID:	294-AMS-15	Location:	Kitchen Dish Area		
Photo:

Manufacturer:	Unknown		
		Description:			
		Right Sink			
		Result:	<1.0	ppb	
		Date Sampled:	3/28/2024	By:	JH
Recommended Action:

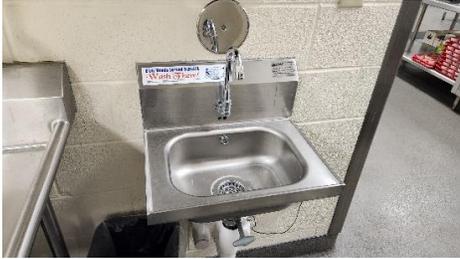
ID:	294-AMS-16	Location:	Kitchen Dish Area	
Photo:

Manufacturer:	Eagle	
		Description:		
		Handwashing Sink		
		Lab Error.		
		Result:	NA	ppb
Date Sampled:	3/28/2024	By:	JH	
Recommended Action:		Mark as Non-Potable/Not for drinking water

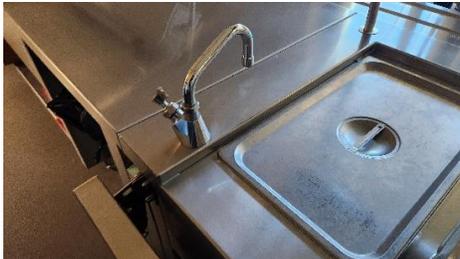
ID:	294-AMS-17	Location:	Kitchen Serving Area		
Photo:

Manufacturer:	Unknown		
		Description:			
		Steam table			
		Result:	1.8	ppb	
		Date Sampled:	3/28/2024	By:	JH
Recommended Action:

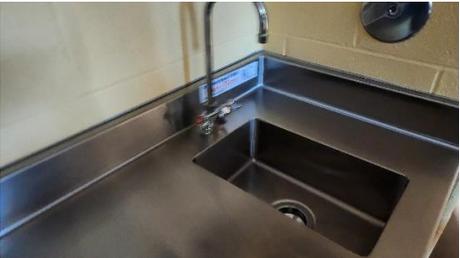
ID:	294-AMS-18	Location:	Kitchen Serving Area	
Photo:

Manufacturer:	Unknown	
		Description:		
		Handwashing Sink		
		Lab error.		
		Result:	NA	ppb
Date Sampled:	3/28/2024	By:	JH	
Recommended Action:		Mark as Non-Potable/Not for drinking water

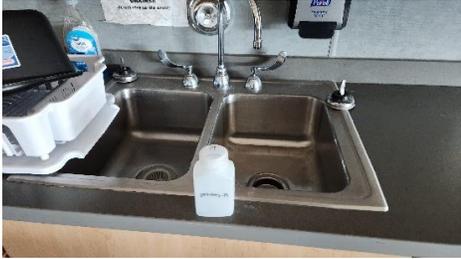
ID:	294-AMS-19	Location:	Room 102	
Photo:

Manufacturer:	Chicago Faucet Co.	
		Description:		
		Left Sink		
		Result:	<1.0	ppb
		Date Sampled:	3/28/2024	By: JH
Recommended Action:

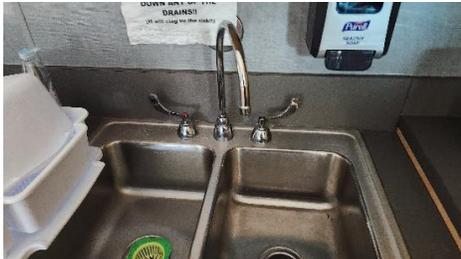
ID:	294-AMS-20	Location:	Room 102	
Photo:

Manufacturer:	Chicago Faucet Co.	
		Description:		
		Right Sink		
		Result:	<1.0	ppb
		Date Sampled:	3/28/2024	By: JH
Recommended Action:

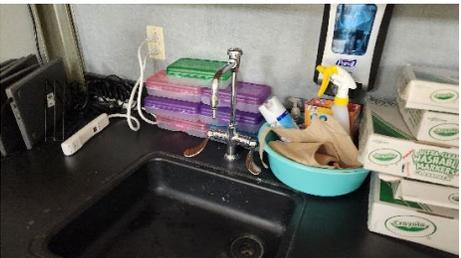
ID:	294-AMS-21	Location:	Room 108	
Photo:

Manufacturer:	Water Saver Faucet Co.	
		Description:		
		Left side, left sink		
		Result:	3.2	ppb
		Date Sampled:	3/28/2024	By: JH
Recommended Action:

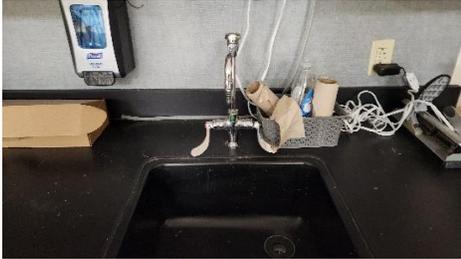
ID:	294-AMS-22	Location:	Room 108	
Photo:

Manufacturer:	Water Saver Faucet Co.	
		Description:		
		Left side, right sink		
		Result:	3.6	ppb
		Date Sampled:	3/28/2024	By: JH
Recommended Action:

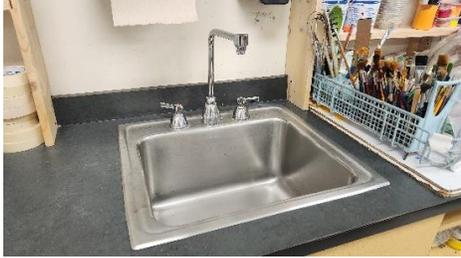
ID:	294-AMS-23	Location:	Room 106	
Photo:

Manufacturer:	Unknown	
		Description:		
		Left Sink		
		Result:	2.1	ppb
		Date Sampled:	3/28/2024	By: JH
Recommended Action:

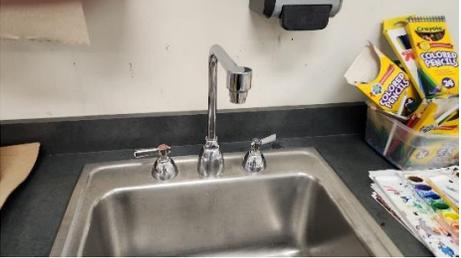
ID:	294-AMS-24	Location:	Room 106	
Photo:

Manufacturer:	Unknown	
		Description:		
		Center Sink		
		Result:	2.2	ppb
		Date Sampled:	3/28/2024	By: JH
Recommended Action:

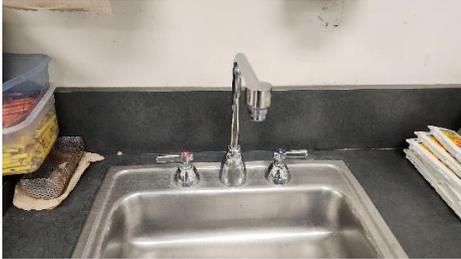
ID:	294-AMS-25	Location:	Room 106		
Photo:

Manufacturer:	Unknown		
		Description:			
		Right Sink			
		Result:	1.9	ppb	
		Date Sampled:	3/28/2024	By:	JH
Recommended Action:

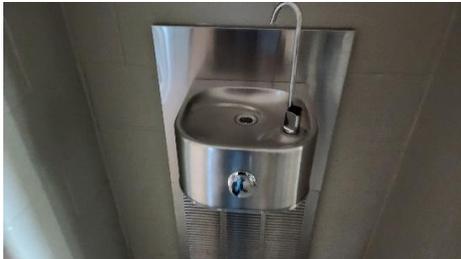
ID:	294-AMS-26	Location:	Hall by Room 106		
Photo:

Manufacturer:	Elkay		
		Description:			
		Drinking Fountain Bottle Filler			
		Result:	<1.0	ppb	
		Date Sampled:	3/28/2024	By:	JH
Recommended Action:

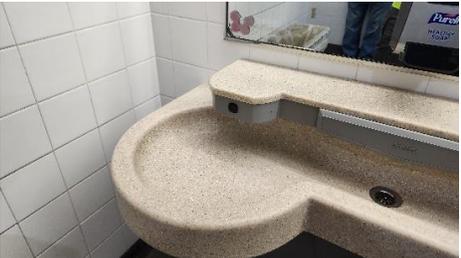
ID:	294-AMS-27	Location:	Girls Restroom by 106		
Photo:

Manufacturer:	Bradley		
		Description:			
		Left handwashing sink			
		Result:	<1.0	ppb	
		Date Sampled:	3/28/2024	By:	JH
Recommended Action:

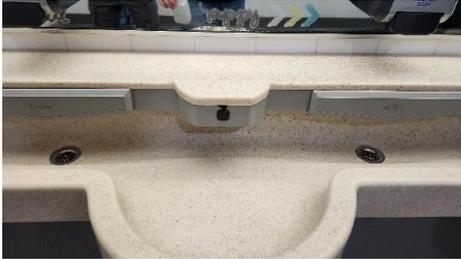
ID:	294-AMS-28	Location:	Girls Restroom by 106	
Photo:

Manufacturer:	Bradley	
		Description:		
		Center handwashing sink		
		Result:	<1.0	ppb
		Date Sampled:	3/28/2024	By: JH
Recommended Action:

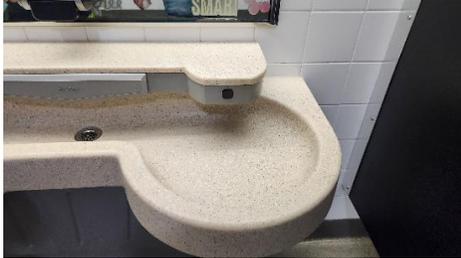
ID:	294-AMS-29	Location:	Girls Restroom by 106	
Photo:

Manufacturer:	Bradley	
		Description:		
		Right handwashing sink		
		Result:	<1.0	ppb
		Date Sampled:	3/28/2024	By: JH
Recommended Action:

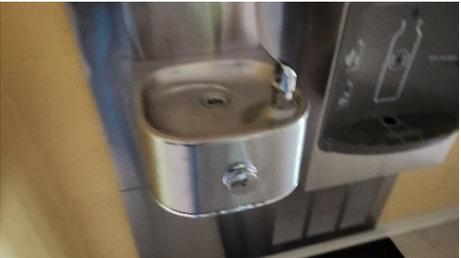
ID:	294-AMS-30	Location:	Hallway by Room 110	
Photo:

Manufacturer:	Elkay	
		Description:		
		Drinking Fountain Bubbler		
		Result:	<1.0	ppb
		Date Sampled:	3/28/2024	By: JH
Recommended Action:

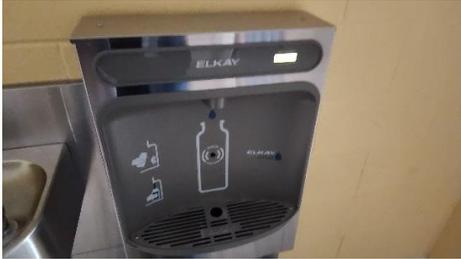
ID:	294-AMS-31	Location:	Hallway by Room 110		
Photo:

Manufacturer:	Elkay		
		Description:			
		Drinking Fountain Bottle Filler			
		Result:	<1.0	ppb	
		Date Sampled:	3/28/2024	By:	JH
Recommended Action:

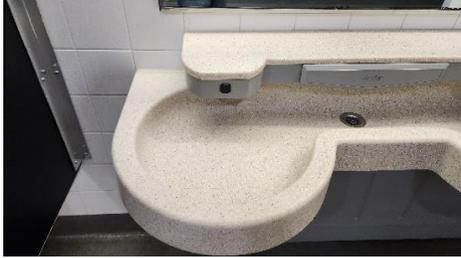
ID:	294-AMS-32	Location:	Boy's Restroom by 110		
Photo:

Manufacturer:	Bradley		
		Description:			
		Left handwashing sink			
		Result:	<1.0	ppb	
		Date Sampled:	3/28/2024	By:	JH
Recommended Action:

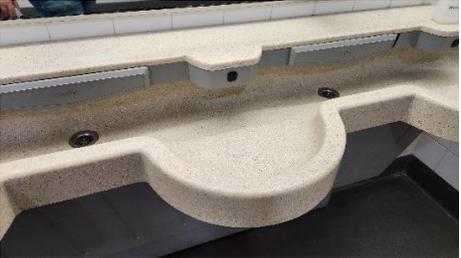
ID:	294-AMS-33	Location:	Boy's Restroom by 110		
Photo:

Manufacturer:	Bradley		
		Description:			
		Center handwashing sink			
		Result:	<1.0	ppb	
		Date Sampled:	3/28/2024	By:	JH
Recommended Action:

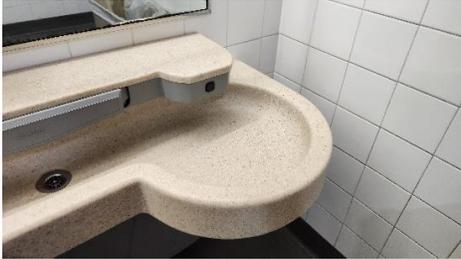
ID:	294-AMS-34	Location:	Boy's Restroom by 110	
Photo:

Manufacturer:	Bradley	
		Description:		
		Right handwashing sink		
		Result:	<1.0	ppb
		Date Sampled:	3/28/2024	By: JH
Recommended Action:

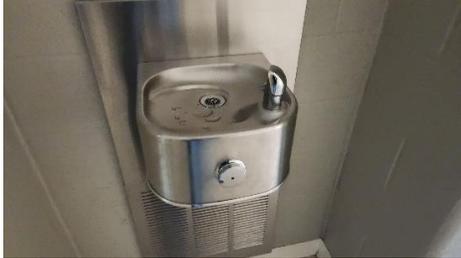
ID:	294-AMS-35	Location:	Hallway by Room 122	
Photo:

Manufacturer:	Elkay	
		Description:		
		Drinking Fountain Bubbler		
		Result:	<1.0	ppb
		Date Sampled:	3/28/2024	By: JH
Recommended Action:

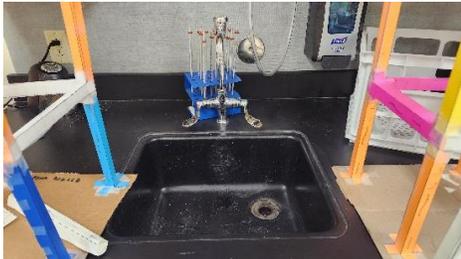
ID:	294-AMS-36	Location:	Room 110	
Photo:

Manufacturer:	Water Saver Faucet Co.	
		Description:		
		Left side, left sink		
		Lab error.		
		Result:	NA	ppb
Date Sampled:	3/28/2024	By: JH		
Recommended Action:		Mark as Non-Potable/Not for drinking water

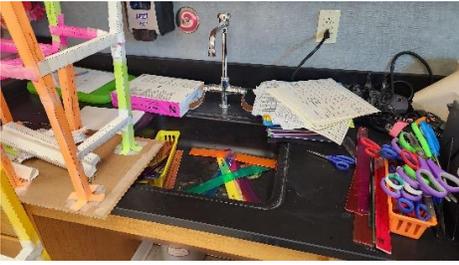
ID:	294-AMS-37	Location:	Room 110
Photo:

Manufacturer:	Water Saver Faucet Co.
		Description:	
		Left side, right sink	
		Lab error,	
		Result:	NA
Date Sampled:	3/28/2024	By: JH	
Recommended Action:	Mark as Non-Potable/Not for drinking water

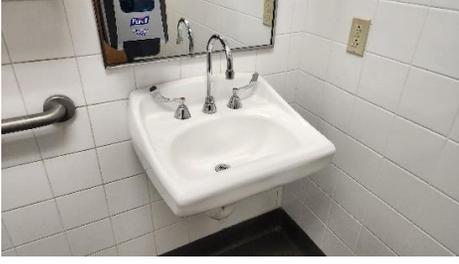
ID:	294-AMS-38	Location:	Faculty Restroom	
Photo:

Manufacturer:	Chicago Faucet Co.	
		Description:		
		Handwashing Sink		
		Result:	2.8	ppb
		Date Sampled:	3/28/2024	By: JH
Recommended Action:

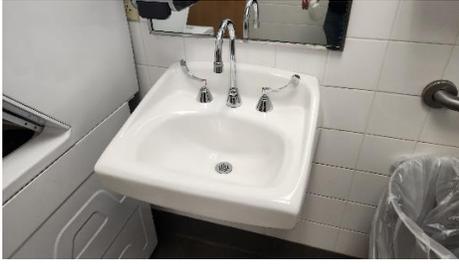
ID:	294-AMS-39	Location:	Hall by Office	
Photo:

Manufacturer:	Chicago Faucet Co.	
		Description:		
		Handwashing Sink		
		Result:	1.9	ppb
		Date Sampled:	3/28/2024	By: JH
Recommended Action:

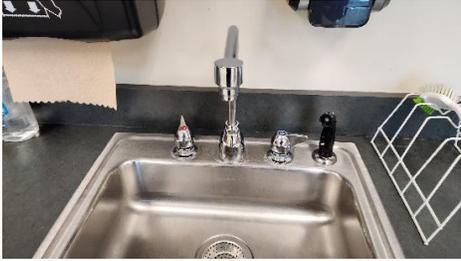
ID:	294-AMS-40	Location:	Room 130
Photo:

Manufacturer:	Chicago Faucet Co.
		Description:	
		Handwashing Sink	
		Result:	1.1 ppb
		Date Sampled:	3/28/2024 By: JH
Recommended Action:

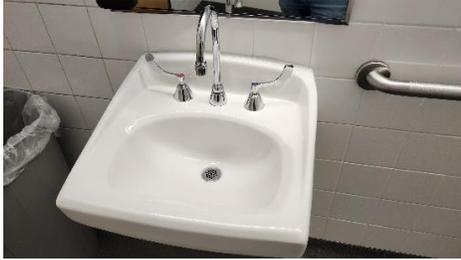
ID:	294-AMS-41	Location:	Teacher's Lounge
Photo:

Manufacturer:	Chicago Faucet Co.
		Description:	
		Handwashing Sink	
		Result:	<1.0 ppb
		Date Sampled:	3/28/2024 By: JH
Recommended Action:

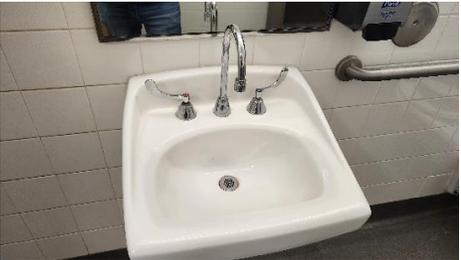
ID:	294-AMS-42	Location:	Teacher's Lounge RR
Photo:

Manufacturer:	Chicago Faucet Co.
		Description:	
		Handwashing Sink	
		Result:	2.4 ppb
		Date Sampled:	3/28/2024 By: JH
Recommended Action:

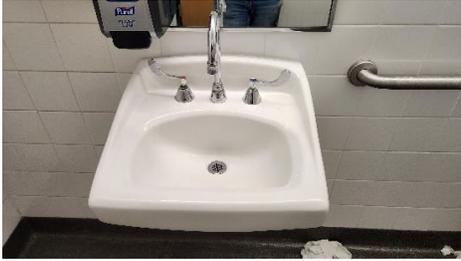
ID:	294-AMS-43	Location:	Office Restroom		
Photo:

Manufacturer:	Chicago Faucet Co.		
		Description:			
		Handwashing Sink			
		Result:	2.6	ppb	
		Date Sampled:	3/28/2024	By:	JH
Recommended Action:

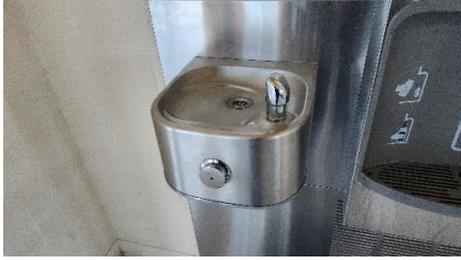
ID:	294-AMS-44	Location:	Hallway by Gym		
Photo:

Manufacturer:	Elkay		
		Description:			
		Drinking Fountain Bubbler			
		Result:	<1.0	ppb	
		Date Sampled:	3/28/2024	By:	JH
Recommended Action:

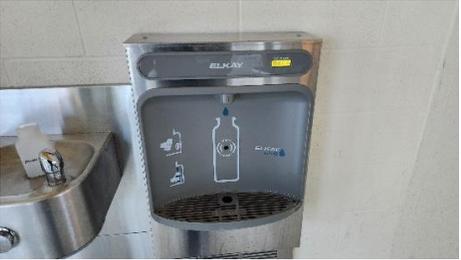
ID:	294-AMS-45	Location:	Hallway by Gym		
Photo:

Manufacturer:	Elkay		
		Description:			
		Drinking Fountain Bottle Filler			
		Result:	<1.0	ppb	
		Date Sampled:	3/28/2024	By:	JH
Recommended Action:

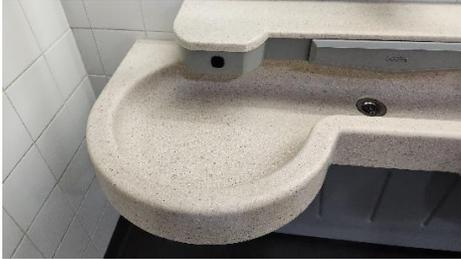
ID:	294-AMS-46	Location:	Boy's Restroom by Gym	
Photo:

Manufacturer:	Bradley	
		Description:		
		Left Handwashing Sink		
		Result:	<1.0	ppb
		Date Sampled:	3/28/2024	By: JH
Recommended Action:

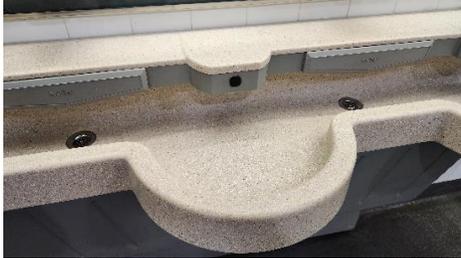
ID:	294-AMS-47	Location:	Boy's Restroom by Gym	
Photo:

Manufacturer:	Bradley	
		Description:		
		Middle Handwashing Sink		
		Result:	<1.0	ppb
		Date Sampled:	3/28/2024	By: JH
Recommended Action:

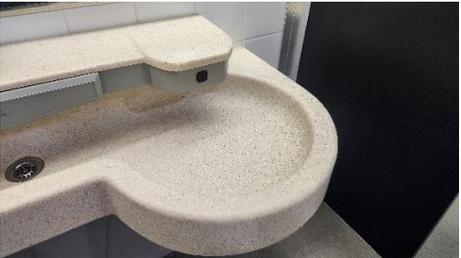
ID:	294-AMS-48	Location:	Boy's Restroom by Gym	
Photo:

Manufacturer:	Bradley	
		Description:		
		Right Handwashing Sink		
		Result:	<1.0	ppb
		Date Sampled:	3/28/2024	By: JH
Recommended Action:

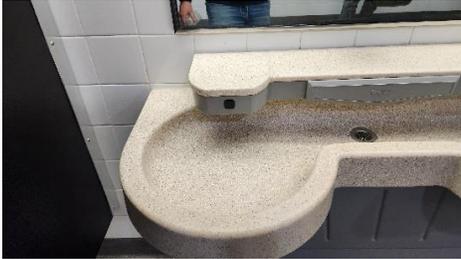
ID:	294-AMS-49	Location:	Girl's Restroom by Gym		
Photo:

Manufacturer:	Bradley		
		Description:			
		Left Handwashing Sink			
		Result:	<1.0	ppb	
		Date Sampled:	3/28/2024	By:	JH
Recommended Action:

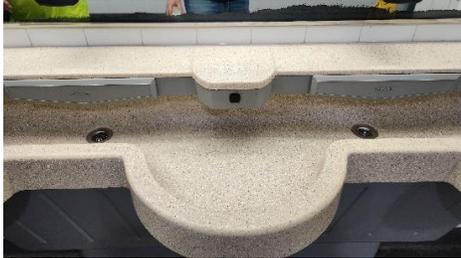
ID:	294-AMS-50	Location:	Girls' Restroom by Gym		
Photo:

Manufacturer:	Bradley		
		Description:			
		Middle Handwashing Sink			
		Result:	<1.0	ppb	
		Date Sampled:	3/28/2024	By:	JH
Recommended Action:

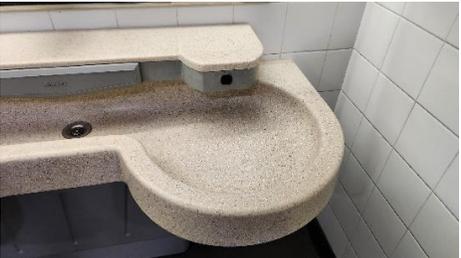
ID:	294-AMS-51	Location:	Girls' Restroom by Gym		
Photo:

Manufacturer:	Bradley		
		Description:			
		Right Handwashing Sink			
		Result:	<1.0	ppb	
		Date Sampled:	3/28/2024	By:	JH
Recommended Action:

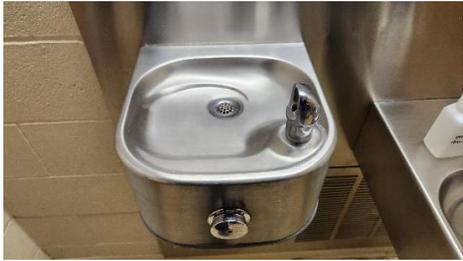
ID:	294-AMS-52	Location:	Gym between Locker RM		
Photo:

Manufacturer:	Elkay		
		Description:			
		Left Drinking Fountain Bubbler			
		Result:	<1.0	ppb	
		Date Sampled:	3/28/2024	By:	JH
Recommended Action:

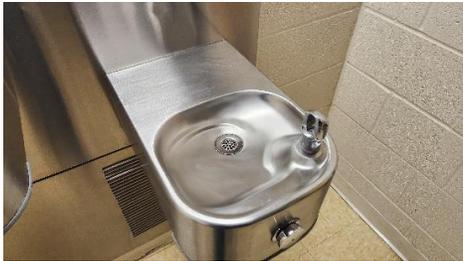
ID:	294-AMS-53	Location:	Gym between Locker RM		
Photo:

Manufacturer:	Elkay		
		Description:			
		Right Drinking Fountain Bubbler			
		Result:	<1.0	ppb	
		Date Sampled:	3/28/2024	By:	JH
Recommended Action:

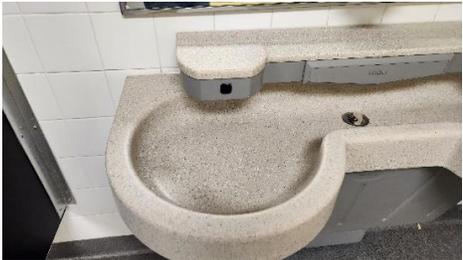
ID:	294-AMS-54	Location:	Boy's Locker Room		
Photo:

Manufacturer:	Bradley		
		Description:			
		Left Handwashing Sink			
		Result:	1.6	ppb	
		Date Sampled:	3/28/2024	By:	JH
Recommended Action:

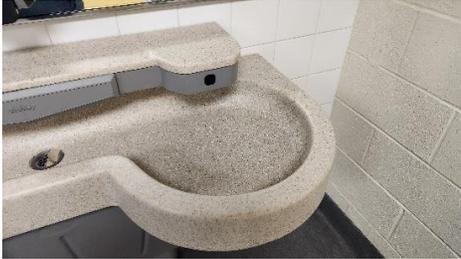
ID:	294-AMS-55	Location:	Boy's Locker Room		
Photo:

Manufacturer:	Bradley		
		Description:			
		Right Handwashing Sink			
		Result:	<1.0	ppb	
		Date Sampled:	3/28/2024	By:	JH
Recommended Action:

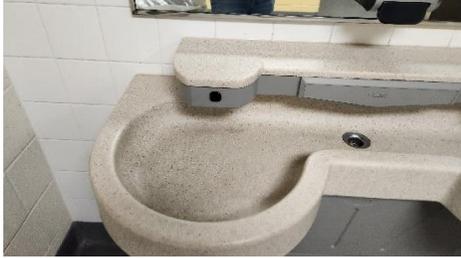
ID:	294-AMS-56	Location:	Girl's Locker Room		
Photo:

Manufacturer:	Bradley		
		Description:			
		Left Handwashing Sink			
		Result:	1	ppb	
		Date Sampled:	3/28/2024	By:	JH
Recommended Action:

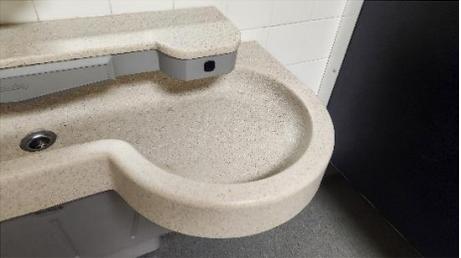
ID:	294-AMS-57	Location:	Girl's Locker Room		
Photo:

Manufacturer:	Bradley		
		Description:			
		Right Handwashing Sink			
		Result:	<1.0	ppb	
		Date Sampled:	3/28/2024	By:	JH
Recommended Action:

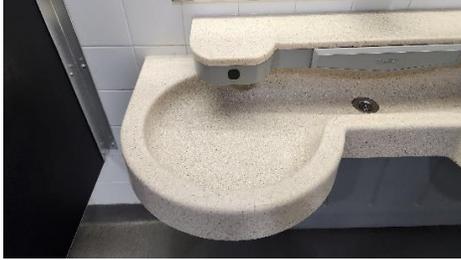
ID:	294-AMS-59	Location:	Boy's Restroom by 022		
Photo:

Manufacturer:	Bradley		
		Description:			
		Left handwashing sink			
		Result:	<1.0	ppb	
		Date Sampled:	3/28/2024	By:	JH
Recommended Action:

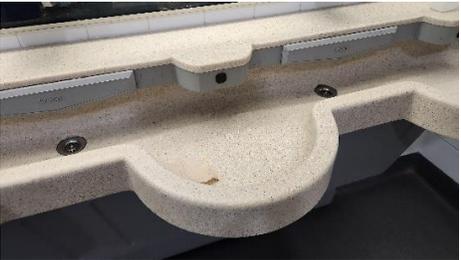
ID:	294-AMS-60	Location:	Boy's Restroom by 022		
Photo:

Manufacturer:	Bradley		
		Description:			
		Middle handwashing sink			
		Result:	<1.0	ppb	
		Date Sampled:	3/28/2024	By:	JH
Recommended Action:

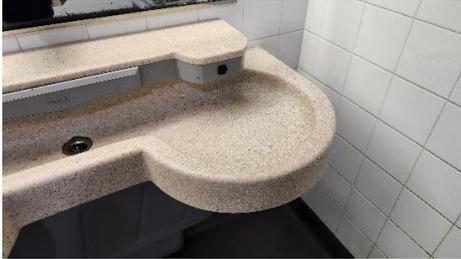
ID:	294-AMS-61	Location:	Boy's Restroom by 022	
Photo:

Manufacturer:	Bradley	
		Description:		
		Right handwashing sink		
		Result:	<1.0	ppb
		Date Sampled:	3/28/2024	By: JH
Recommended Action:

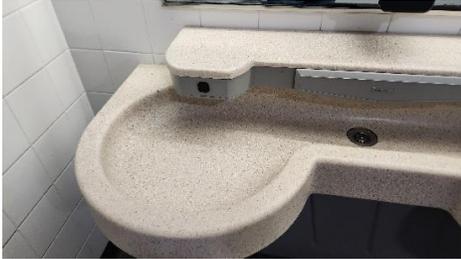
ID:	294-AMS-64	Location:	Girls Restroom by 012	
Photo:

Manufacturer:	Bradley	
		Description:		
		Left Handwashing Sink		
		Result:	<1.0	ppb
		Date Sampled:	3/28/2024	By: JH
Recommended Action:

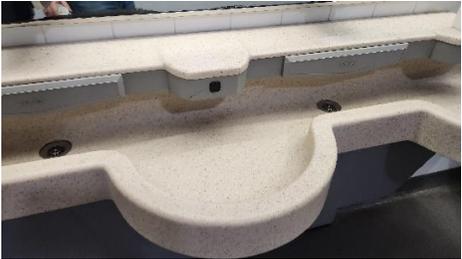
ID:	294-AMS-65	Location:	Girl's Restroom by 012	
Photo:

Manufacturer:	Bradley	
		Description:		
		Middle Handwashing Sink		
		Result:	<1.0	ppb
		Date Sampled:	3/28/2024	By: JH
Recommended Action:

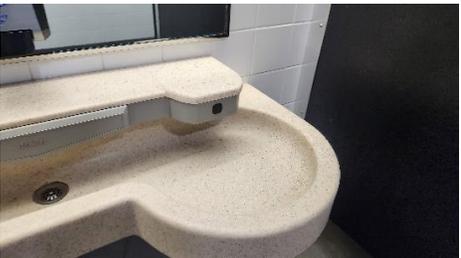
ID:	294-AMS-66	Location:	Girl's Restroom by 012	
Photo:

Manufacturer:	Bradley	
		Description:		
		Right Handwashing Sink		
		Result:	1.1	ppb
		Date Sampled:	3/28/2024	By: JH
Recommended Action:

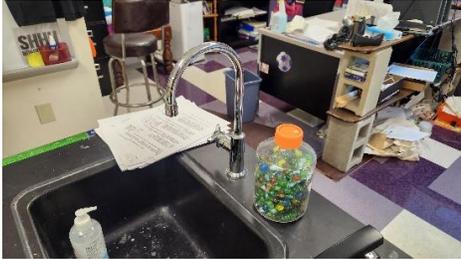
Manufacturer:	Water Saver Faucet Co.	
		Description:		
		Left side, teacher's island sink		
		Result:	16.5	ppb
		Date Sampled:	3/28/2024	By: JH
Recommended Action:	Mark as Non-Potable/Not for drinking water

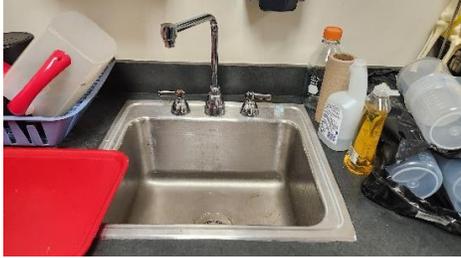
ID:	294-AMS-68	Location:	Room 012 Lab Storage	
Photo:

Manufacturer:	Chicago Faucet Co.	
		Description:		
		Sink		
		Result:	2.8	ppb
		Date Sampled:	3/28/2024	By: JH
Recommended Action:

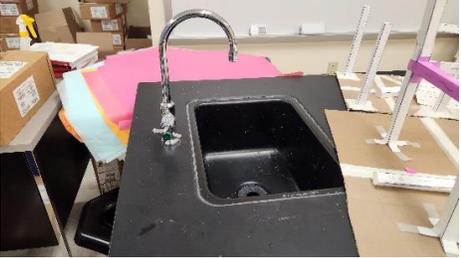
Manufacturer:	Chicago Faucet Co.	
		Description:		
		Teacher's Island, Left side		
		Result:	15.5	ppb
		Date Sampled:	3/28/2024	By: JH
Recommended Action:	Mark as Non-Potable/Not for drinking water

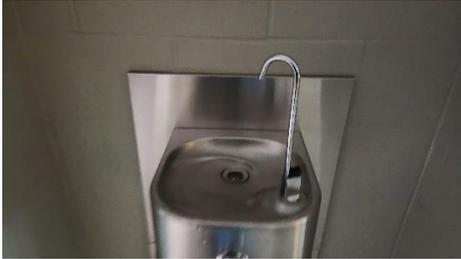
ID:	294-AMS-70	Location:	Hall by Room 012	
Photo:

Manufacturer:	Elkay	
		Description:		
		Drinking Fountain Bubbler		
		Result:	<1.0	ppb
Date Sampled:		1/15/2024	By:	JH
Recommended Action:

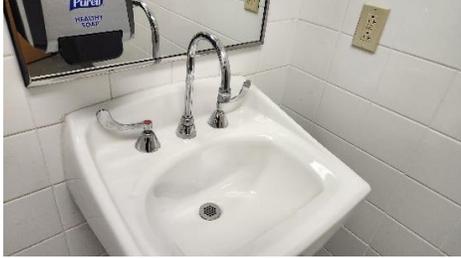
ID:	294-AMS-71	Location:	Faculty Restroom by 012	
Photo:

Manufacturer:	Chicago Faucet Co.	
		Description:		
		Handwashing Sink		
		Result:	<1.0	ppb
Date Sampled:		3/28/2024	By:	JH
Recommended Action:
