May 10, 2024

RE: Drinking Water Sampling – Seckman Senior High School
2800 Seckman Rd, Imperial, MO 63052
Project Number: 923294

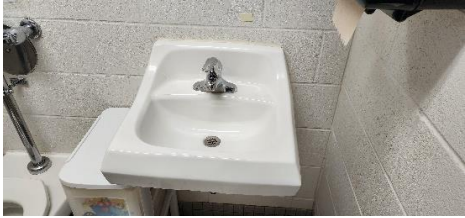
ID:	294-SHS-01	Location:	Kitchen Restroom	
Photo:

Manufacturer:	Moen	
		Description:		
		Handwashing Sink		
		Result:	<1.0	ppb
		Date Sampled:	3/27/2024	By: JH
Recommended Action:

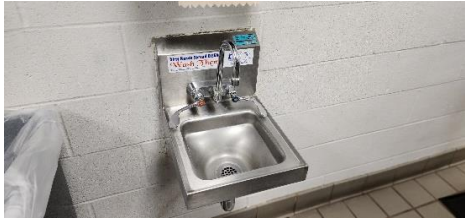
ID:	294-SHS-02	Location:	Kitchen	
Photo:

Manufacturer:	Unknown	
		Description:		
		Handwashing sink		
		Result:	<1.0	ppb
		Date Sampled:	3/27/2024	By: JH
Recommended Action:

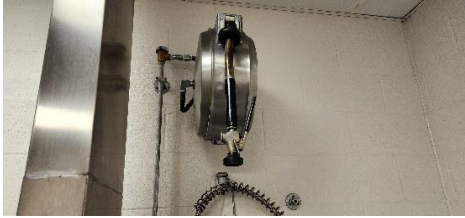
ID:	294-SHS-04	Location:	Kitchen Dish Area	
Photo:

Manufacturer:	Unknown	
		Description:		
		Reel Dish Spray		
		Result:	1.4	ppb
		Date Sampled:	3/27/2024	By:
Recommended Action:

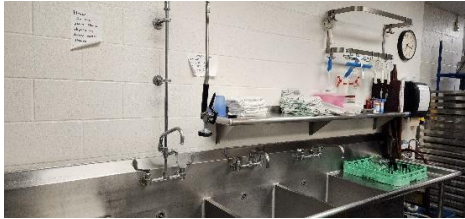
ID:	294-SHS-05	Location:	Kitchen Dish Area	
Photo:

Manufacturer:	Unknown	
		Description:		
		Left sink		
		Result:	17.8	ppb
		Date Sampled:	3/27/2024	By:
Recommended Action:		Replace Fixture/Unit and Resample

In accordance with the requirements set forth in Missouri Bill 681/662, fixtures exhibiting lead concentrations above 5 ppb must be remediated by replacement of lead-containing pipes, solder, fittings or fixtures with lead-free components, or the school shall install filtration at each point where water enters the building until such time as the source can be remediated. If installing a filter is not feasible, the school shall provide purified water at each outlet inventoried.

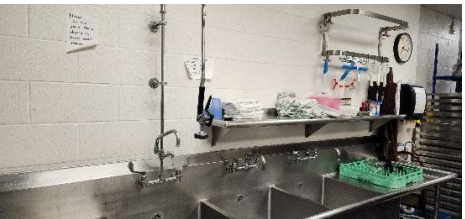
ID:	294-SHS-06	Location:	Kitchen Dish Area	
Photo:

Manufacturer:	Unknown	
		Description:		
		Kitchen Dish Sprayer		
		Result:	2.6	ppb
		Date Sampled:	3/27/2024	By:
Recommended Action:

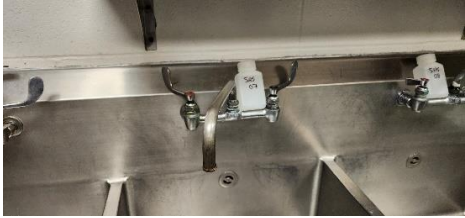
ID:	294-SHS-07	Location:	Kitchen Dish Area	
Photo:

Manufacturer:	Unknown	
		Description:		
		Center Sink		
		Result:	4	ppb
		Date Sampled:	3/27/2024	By:
Recommended Action:

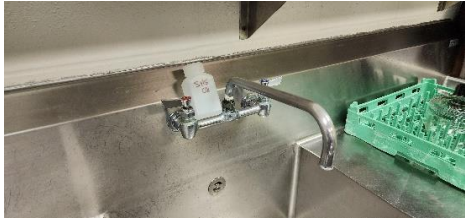
ID:	294-SHS-08	Location:	Kitchen Dish Area	
Photo:

Manufacturer:	Unknown	
		Description:		
		Right sink		
		Result:	<1.0	ppb
		Date Sampled:	3/27/2024	By:
Recommended Action:

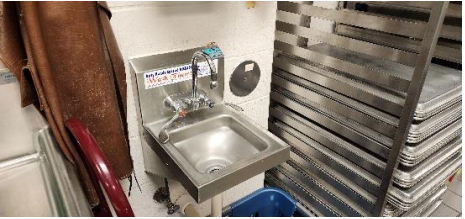
ID:	294-SHS-09	Location:	Kitchen Dish Area	
Photo:

Manufacturer:	Unknown	
		Description:		
		Handwashing Sink		
		Result:	13.5	ppb
		Date Sampled:	3/27/2024	By:
Recommended Action:		Mark as nonpotable water/Not drinking water

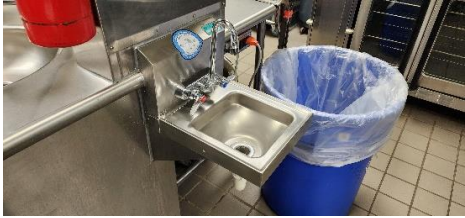
ID:	294-SHS-10	Location:	Kitchen	
Photo:

Manufacturer:	Unknown	
		Description:		
		Handwashing sink		
		Result:	<1.0	ppb
		Date Sampled:	3/27/2024	By: JH
Recommended Action:

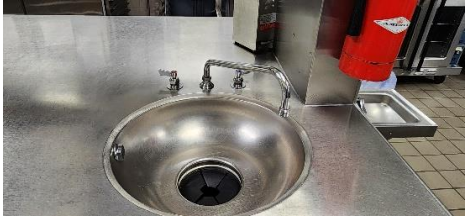
ID:	294-SHS-11	Location:	Kitchen	
Photo:

Manufacturer:	Unknown	
		Description:		
		Garbage Disposal		
		Result:	15.5	ppb
		Date Sampled:	3/27/2024	By: JH
Recommended Action:		Replace Fixture/Unit and Resample

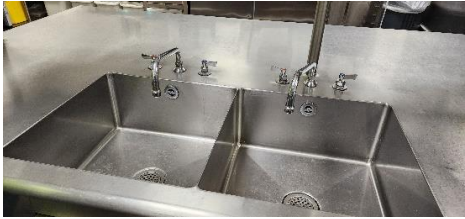
ID:	294-SHS-12	Location:	Kitchen	
Photo:

Manufacturer:	Unknown	
		Description:		
		Left prep area sink		
		Result:	11.6	ppb
		Date Sampled:	3/27/2024	By: JH
Recommended Action:		Replace Fixture/Unit and Resample

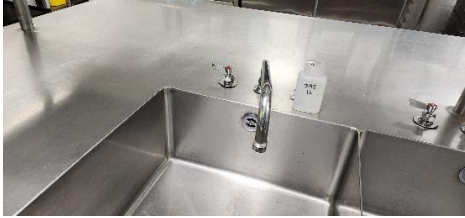
ID:	294-SHS-13	Location:	Kitchen	
Photo:

Manufacturer:	Unknown	
		Description:		
		Right prep area sink		
		Result:	4.2	ppb
		Date Sampled:	3/27/2024	By: JH
Recommended Action:

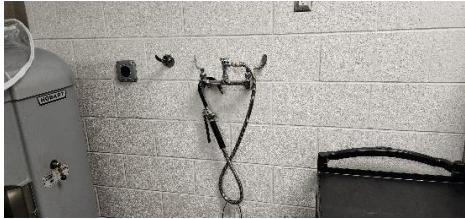
ID:	294-SHS-14	Location:	Kitchen	
Photo:

Manufacturer:	Unknown	
		Description:		
		Back wall pot filler		
		Result:	117	ppb
		Date Sampled:	3/27/2024	By: JH
Recommended Action:		Replace Fixture/Unit and Resample

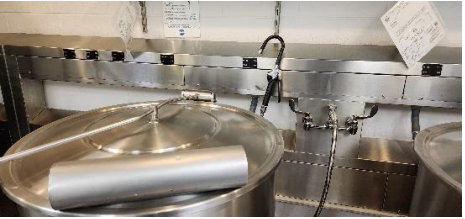
ID:	294-SHS-15	Location:	Kitchen	
Photo:

Manufacturer:	Unknown	
		Description:		
		Pot filler on left kettle		
		Result:	<1.0	ppb
		Date Sampled:	3/27/2024	By: JH
Recommended Action:

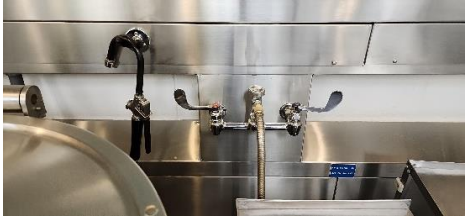
ID:	294-SHS-16	Location:	Kitchen	
Photo:

Manufacturer:	Unknown	
		Description:		
		Right kettle pot filler		
		Result:	3.5	ppb
		Date Sampled:	3/27/2024	By: JH
Recommended Action:

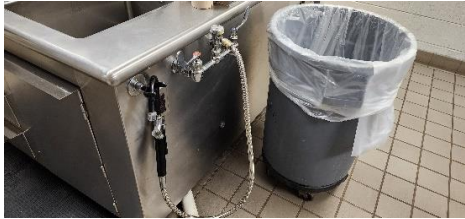
ID:	294-SHS-17	Location:	Kitchen	
Photo:

Manufacturer:	Unknown	
		Description:		
		Pot filler on island		
		Result:	4.6	ppb
		Date Sampled:	3/27/2024	By: JH
Recommended Action:

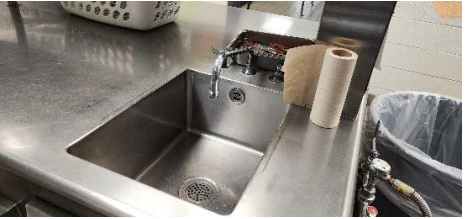
ID:	294-SHS-18	Location:	Kitchen	
Photo:

Manufacturer:	Unknown	
		Description:		
		Island Sink		
		Result:	9.3	ppb
		Date Sampled:	3/27/2024	By: JH
Recommended Action:		Replace Fixture/Unit and Resample

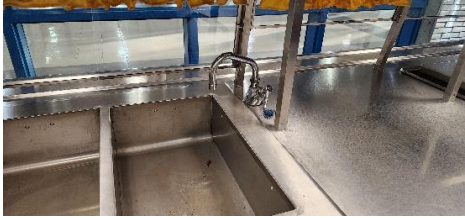
ID:	294-SHS-19	Location:	Serving area	
Photo:

Manufacturer:	Unknown	
		Description:		
		Steam table line 1 sink		
		Result:	9.6	ppb
		Date Sampled:	3/27/2024	By: JH
Recommended Action:		Replace Fixture/Unit and Resample

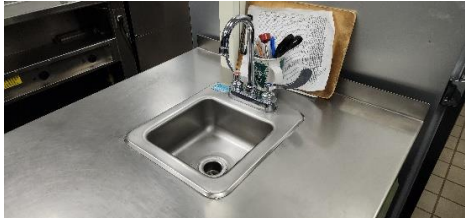
ID:	294-SHS-20	Location:	Serving Area	
Photo:

Manufacturer:	Unknown	
		Description:		
		Center Island Sink		
		Result:	1.6	ppb
		Date Sampled:	3/27/2024	By: JH
Recommended Action:

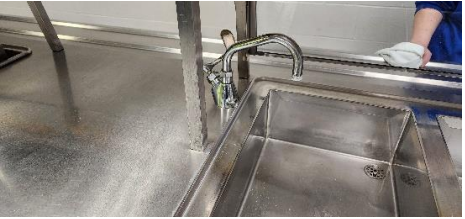
ID:	294-SHS-21	Location:	Serving Area	
Photo:

Manufacturer:	Unknown	
		Description:		
		Steam Table line 2 sink		
		Result:	<1.0	ppb
		Date Sampled:	3/27/2024	By: JH
Recommended Action:

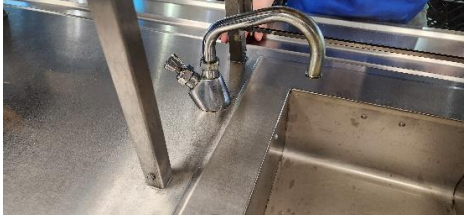
ID:	294-SHS-22	Location:	Serving Area	
Photo:

Manufacturer:	Unknown	
		Description:		
		Steam Table line 3 sink		
		Result:	5.4	ppb
		Date Sampled:	3/27/2024	By: JH
Recommended Action:		Replace Fixture/Unit and Resample

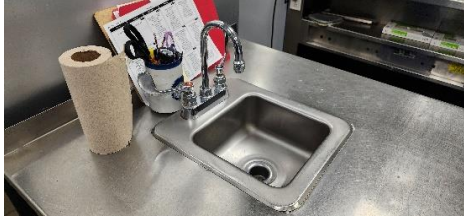
ID:	294-SHS-23	Location:	Serving Area	
Photo:

Manufacturer:	Unknown	
		Description:		
		Center Island Sink		
		Result:	7.6	ppb
		Date Sampled:	3/27/2024	By: JH
Recommended Action:		Replace Fixture/Unit and Resample

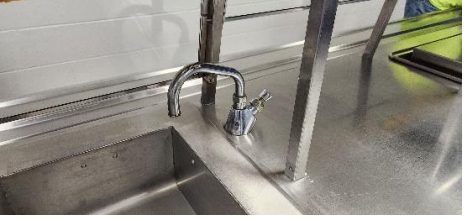
ID:	294-SHS-24	Location:	Serving Area	
Photo:

Manufacturer:	Unknown	
		Description:		
		Steam Table line 4 sink		
		Result:	6.2	ppb
		Date Sampled:	3/27/2024	By: JH
Recommended Action:		Replace Fixture/Unit and Resample

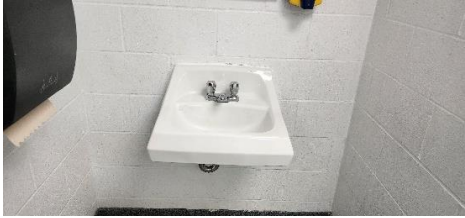
ID:	294-SHS-25	Location:	Women's Restroom	
Photo:

Manufacturer:	Chicago Faucet Co.	
		Description:		
		Handwashing Sink by cafeteria		
		Result:	<1.0	ppb
		Date Sampled:	3/27/2024	By: JH
Recommended Action:

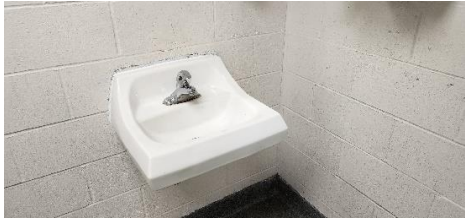
ID:	294-SHS-26	Location:	Men's Restroom	
Photo:

Manufacturer:	Moen	
		Description:		
		Handwashing Sink by cafeteria		
		Result:	<1.0	ppb
		Date Sampled:	3/27/2024	By: JH
Recommended Action:

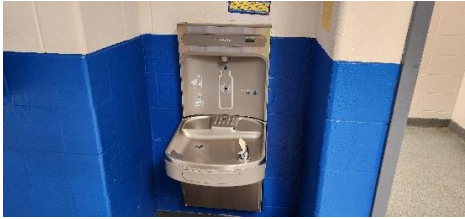
ID:	294-SHS-27	Location:	Hall outside Cafeteria	
Photo:

Manufacturer:	Elkay	
		Description:		
		Drinking fountain bubbler		
		Result:	<1.0	ppb
		Date Sampled:	3/27/2024	By: JH
Recommended Action:

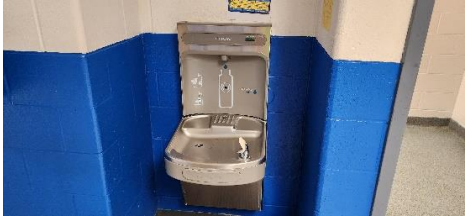
ID:	294-SHS-28	Location:	Hall outside Cafeteria	
Photo:

Manufacturer:	Elkay	
		Description:		
		Drinking fountain bottle filler		
		Result:	<1.0	ppb
		Date Sampled:	3/27/2024	By: JH
Recommended Action:

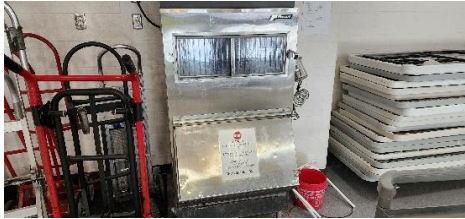
ID:	294-SHS-29	Location:	Cafeteria	
Photo:

Manufacturer:	Follett	
		Description:		
		Ice Machine		
		Not in Operation at time of testing.		
		Result:	NA	ppb
Date Sampled:	3/27/2024	By: JH		
Recommended Action:		Sample Prior to Returning to Service

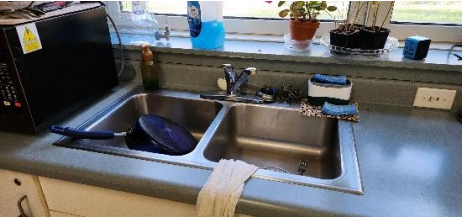
ID:	294-SHS-30	Location:	Room 105	
Photo:

Manufacturer:	Unknown	
		Description:		
		Far wall, left sink		
		Result:	<1.0	ppb
		Date Sampled:	3/27/2024	By: JH
Recommended Action:

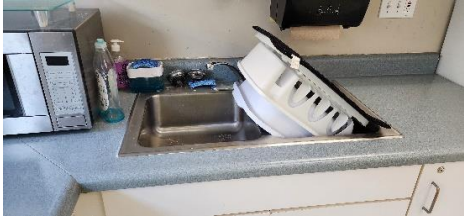
ID:	294-SHS-31	Location:	Room 105	
Photo:

Manufacturer:	Unknown	
		Description:		
		Kitchen Sink		
		Result:	<1.0	ppb
		Date Sampled:	3/27/2024	By: JH
Recommended Action:

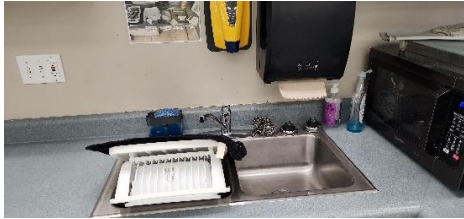
ID:	294-SHS-32	Location:	Room 105	
Photo:

Manufacturer:	Unknown	
		Description:		
		Kitchen Sink		
		Result:	<1.0	ppb
		Date Sampled:	3/27/2024	By: JH
Recommended Action:

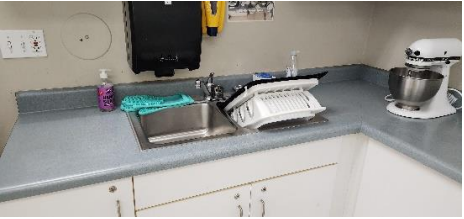
ID:	294-SHS-33	Location:	Room 105	
Photo:

Manufacturer:	Unknown	
		Description:		
		Kitchen Sink		
		Result:	<1.0	ppb
		Date Sampled:	3/27/2024	By: JH
Recommended Action:

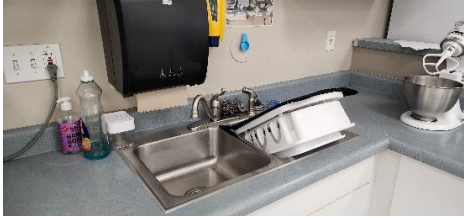
ID:	294-SHS-34	Location:	Room 105	
Photo:

Manufacturer:	Unknown	
		Description:		
		Kitchen Sink		
		Result:	<1.0	ppb
		Date Sampled:	3/27/2024	By: JH
Recommended Action:

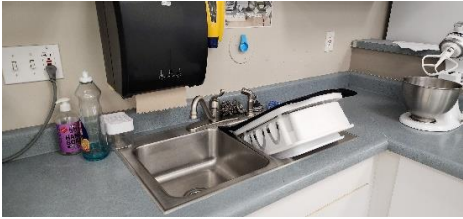
ID:	294-SHS-35	Location:	Room 105	
Photo:

Manufacturer:	Unknown	
		Description:		
		Kitchen Sink sprayer		
		Result:	<1.0	ppb
		Date Sampled:	3/27/2024	By: JH
Recommended Action:

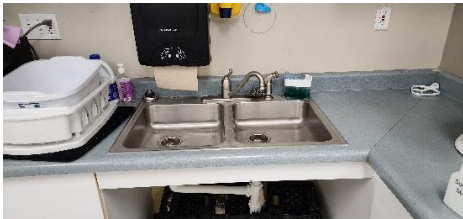
ID:	294-SHS-36	Location:	Room 105	
Photo:

Manufacturer:	Unknown	
		Description:		
		Kitchen Sink		
		Result:	<1.0	ppb
		Date Sampled:	3/27/2024	By: JH
Recommended Action:

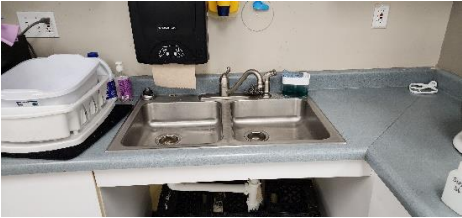
ID:	294-SHS-37	Location:	Room 105	
Photo:

Manufacturer:	Unknown	
		Description:		
		Kitchen Sprayer		
		Result:	<1.0	ppb
		Date Sampled:	3/27/2024	By: JH
Recommended Action:

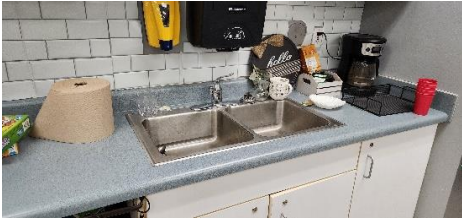
ID:	294-SHS-38	Location:	Room 107	
Photo:

Manufacturer:	Unknown	
		Description:		
		Sink		
		Result:	<1.0	ppb
		Date Sampled:	3/27/2024	By: JH
Recommended Action:

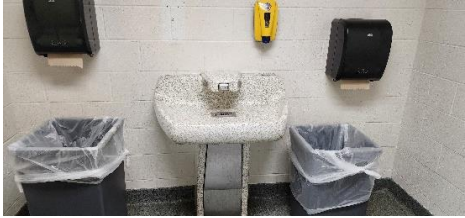
ID:	294-SHS-40	Location:	Men's Restroom	
Photo:

Manufacturer:	Unknown	
		Description:		
		By 105-114 Hall, left handwashing sink		
		Result:	<1.0	ppb
		Date Sampled:	3/27/2024	By: JH
Recommended Action:

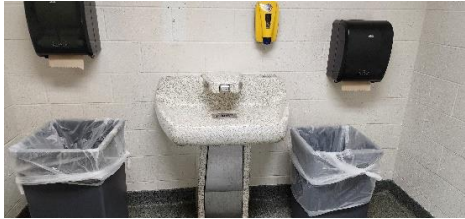
ID:	294-SHS-41	Location:	Men's Restroom	
Photo:

Manufacturer:	Unknown	
		Description:		
		By 105-114 Hall, middle handwashing sink		
		Result:	<1.0	ppb
		Date Sampled:	3/27/2024	By: JH
Recommended Action:

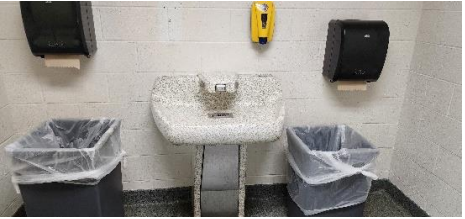
ID:	294-SHS-42	Location:	Men's Restroom	
Photo:

Manufacturer:	Unknown	
		Description:		
		By 105-114 Hall, right handwashing sink		
		Result:	<1.0	ppb
		Date Sampled:	3/27/2024	By: JH
Recommended Action:

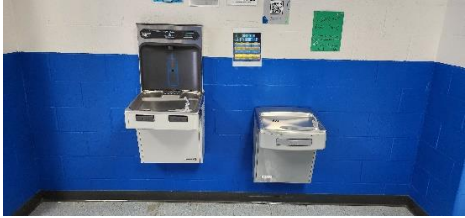
ID:	294-SHS-43	Location:	105-114 Hallway	
Photo:

Manufacturer:	Halsey Taylor	
		Description:		
		Drinking fountain bubbler		
		Result:	<1.0	ppb
		Date Sampled:	3/27/2024	By: JH
Recommended Action:

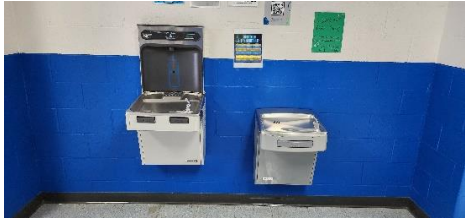
ID:	294-SHS-44	Location:	105-114 Hallway	
Photo:

Manufacturer:	Halsey Taylor	
		Description:		
		Drinking fountain bottle filler		
		Result:	<1.0	ppb
		Date Sampled:	3/27/2024	By: JH
Recommended Action:

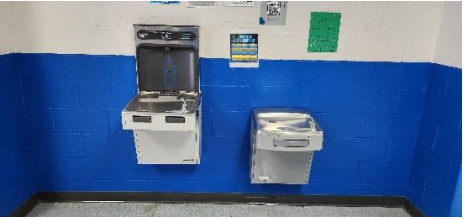
ID:	294-SHS-45	Location:	105-114 Hallway	
Photo:

Manufacturer:	Oasis	
		Description:		
		Drinking fountain bubbler		
		Result:	<1.0	ppb
		Date Sampled:	3/27/2024	By: JH
Recommended Action:

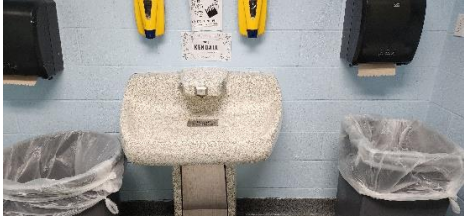
ID:	294-SHS-46	Location:	104-115 Hallway	
Photo:

Manufacturer:	Unknown	
		Description:		
		Left handwashing sink in women's restroom		
		Result:	<1.0	ppb
		Date Sampled:	3/27/2024	By: JH
Recommended Action:

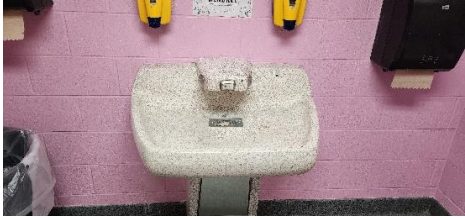
ID:	294-SHS-49	Location:	118-134 Hallway	
Photo:

Manufacturer:	Unknown	
		Description:		
		Left handwashing Sink in Women's Restroom		
		Result:	<1.0	ppb
		Date Sampled:	3/27/2024	By: JH
Recommended Action:

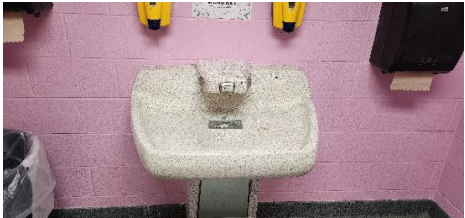
ID:	294-SHS-50	Location:	118-134 Hallway	
Photo:

Manufacturer:	Unknown	
		Description:		
		Middle handwashing Sink in Women's Restroom		
		Result:	<1.0	ppb
		Date Sampled:	3/27/2024	By: JH
Recommended Action:

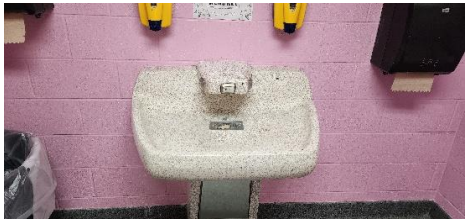
ID:	294-SHS-51	Location:	118-134 Hallway	
Photo:

Manufacturer:	Unknown	
		Description:		
		Right handwashing Sink in Women's Restroom		
		Result:	<1.0	ppb
		Date Sampled:	3/27/2024	By: JH
Recommended Action:

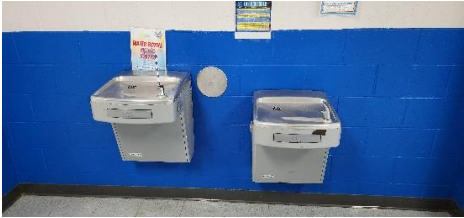
ID:	294-SHS-52	Location:	Hall Across from Library	
Photo:

Manufacturer:	Oasis	
		Description:		
		Left drinking fountain bottle filler		
		Result:	<1.0	ppb
		Date Sampled:	3/27/2024	By: JH
Recommended Action:

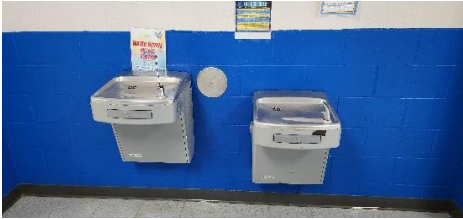
ID:	294-SHS-53	Location:	Hall Across from Library	
Photo:

Manufacturer:	Oasis	
		Description:		
		Right drinking fountain bubbler		
		Result:	<1.0	ppb
		Date Sampled:	3/27/2024	By: JH
Recommended Action:

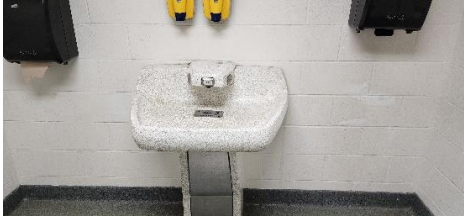
ID:	294-SHS-55	Location:	118-134 Hallway	
Photo:

Manufacturer:	Unknown	
		Description:		
		Men's restroom, middle handwashing sink		
		Result:	<1.0	ppb
		Date Sampled:	3/27/2024	By:
Recommended Action:

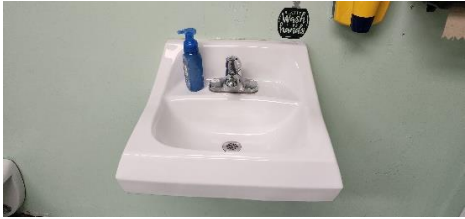
ID:	294-SHS-57	Location:	Room 123 Restroom	
Photo:

Manufacturer:	DTA	
		Description:		
		Handwashing Sink		
		Result:	<1.0	ppb
		Date Sampled:	3/27/2024	By:
Recommended Action:

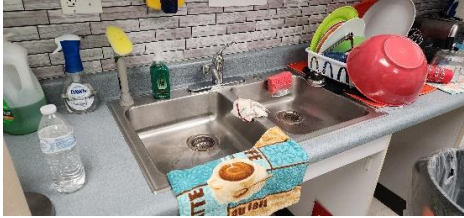
ID:	294-SHS-58	Location:	Room 123	
Photo:

Manufacturer:	Unknown	
		Description:		
		Sink		
		Result:	<1.0	ppb
Date Sampled:		3/27/2024	By:	JH
Recommended Action:

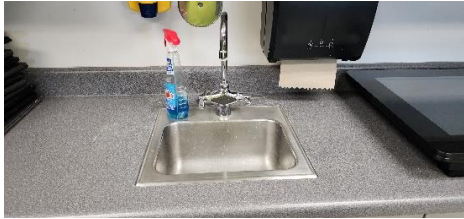
ID:	294-SHS-59	Location:	Librayr office	
Photo:

Manufacturer:	Chicago Faucet Co.	
		Description:		
		Sink		
		Result:	<1.0	ppb
Date Sampled:		3/27/2024	By:	JH
Recommended Action:

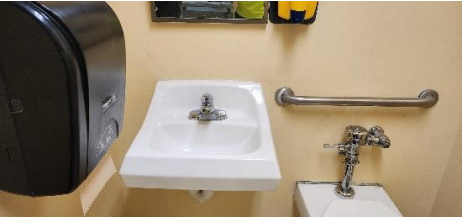
ID:	294-SHS-60	Location:	Office Restroom	
Photo:

Manufacturer:	Unknown	
		Description:		
		Handwashing Sink		
		Result:	<1.0	ppb
Date Sampled:		3/27/2024	By:	JH
Recommended Action:

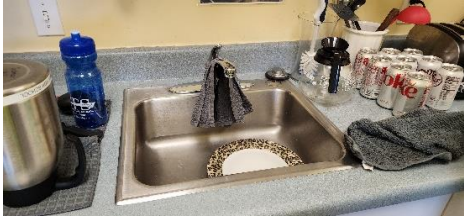
ID:	294-SHS-61	Location:	Office Lounge	
Photo:

Manufacturer:	Unknown	
		Description:		
		Sink		
		Result:	<1.0	ppb
		Date Sampled:	3/27/2024	By: JH
Recommended Action:

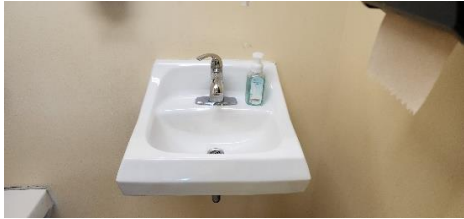
ID:	294-SHS-62	Location:	Office Restroom	
Photo:

Manufacturer:	Unknown	
		Description:		
		Handsink in restroom by lounge. Not first draw.		
		Result:	<1.0	ppb
		Date Sampled:	3/27/2024	By: JH
Recommended Action:

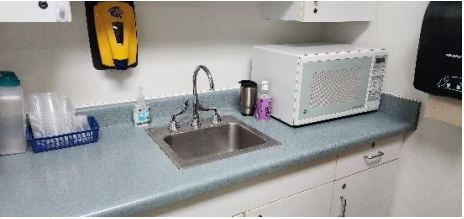
ID:	294-SHS-63	Location:	Nurse's Office	
Photo:

Manufacturer:	Chicago Faucet Co.	
		Description:		
		Sink		
		Result:	<1.0	ppb
		Date Sampled:	3/27/2024	By: JH
Recommended Action:

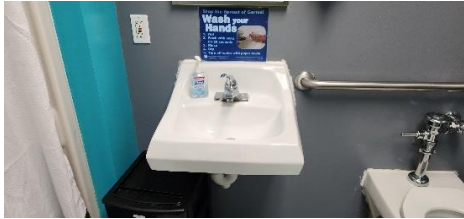
ID:	294-SHS-65	Location:	Nurse's Office Restroom	
Photo:

Manufacturer:	Unknown	
		Description:		
		Handwashing Sink		
		Result:	<1.0	ppb
		Date Sampled:	3/27/2024	By: JH
Recommended Action:

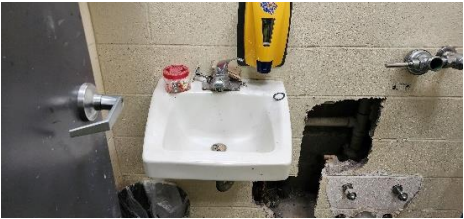
ID:	294-SHS-66	Location:	Stage Restroom	
Photo:

Manufacturer:	Unknown	
		Description:		
		Handwashing Sink		
		Result:	1.4	ppb
		Date Sampled:	3/27/2024	By: JH
Recommended Action:

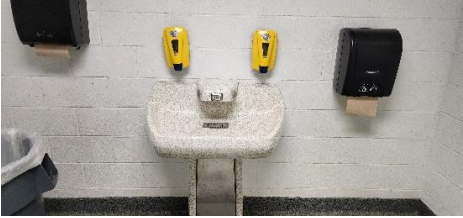
ID:	294-SHS-67	Location:	Outside gym	
Photo:

Manufacturer:	Unknown	
		Description:		
		Men's restroom left handwashing sink		
		Result:	3.1	ppb
		Date Sampled:	3/27/2024	By: JH
Recommended Action:

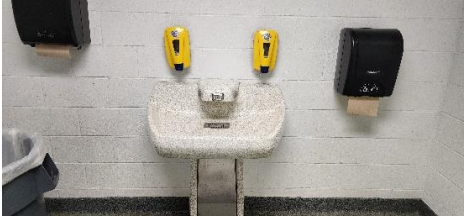
ID:	294-SHS-68	Location:	Outside gym	
Photo:

Manufacturer:	Unknown	
		Description:		
		Men's restroom middle handwashing sink		
		Result:	<1.0	ppb
		Date Sampled:	3/27/2024	By: JH
Recommended Action:

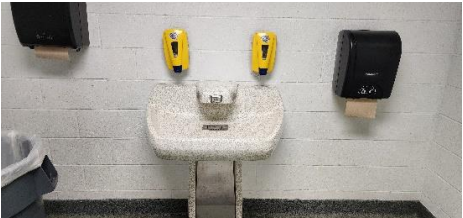
ID:	294-SHS-69	Location:	Outside gym	
Photo:

Manufacturer:	Unknown	
		Description:		
		Men's restroom right handwashing sink		
		Result:	2.9	ppb
		Date Sampled:	3/27/2024	By: JH
Recommended Action:

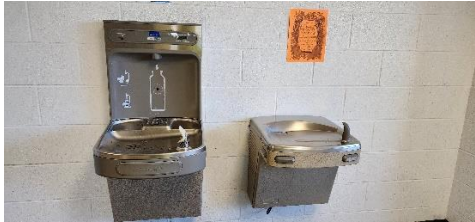
ID:	294-SHS-70	Location:	Hall Outside Gym	
Photo:

Manufacturer:	Elkay	
		Description:		
		Left drinking fountain bubbler		
		Result:	<1.0	ppb
		Date Sampled:	3/27/2024	By: JH
Recommended Action:

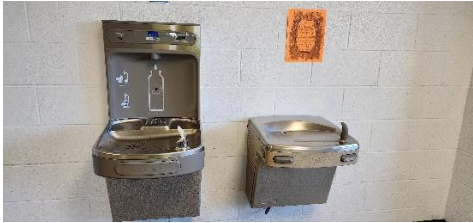
ID:	294-SHS-71	Location:	Hall Outside Gym	
Photo:

Manufacturer:	Elkay	
		Description:		
		Left drinking fountain bottle filler		
		Result:	<1.0	ppb
		Date Sampled:	3/27/2024	By: JH
Recommended Action:

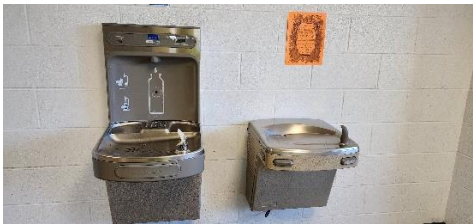
ID:	294-SHS-72	Location:	Hall Outside Gym	
Photo:

Manufacturer:	Oasis	
		Description:		
		Right drinking fountain bubbler		
		Result:	<1.0	ppb
		Date Sampled:	3/27/2024	By: JH
Recommended Action:

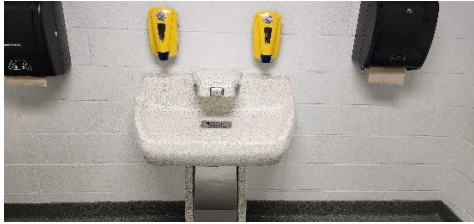
ID:	294-SHS-73	Location:	Hallway Outisde Gym	
Photo:

Manufacturer:	Unknown	
		Description:		
		Women's restroom left handwashing sink		
		Result:	1.1	ppb
		Date Sampled:	3/27/2024	By: JH
Recommended Action:

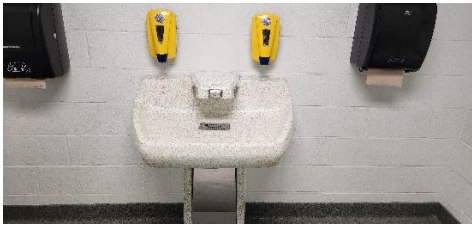
ID:	294-SHS-74	Location:	Hallway Outisde Gym	
Photo:

Manufacturer:	Unknown	
		Description:		
		Women's restroom middle handwashing sink		
		Result:	<1.0	ppb
		Date Sampled:	3/27/2024	By: JH
Recommended Action:

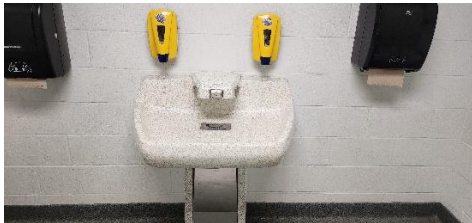
ID:	294-SHS-75	Location:	Hallway Outisde Gym	
Photo:

Manufacturer:	Unknown	
		Description:		
		Women's restroom right handwashing sink		
		Result:	1.7	ppb
		Date Sampled:	3/27/2024	By: JH
Recommended Action:

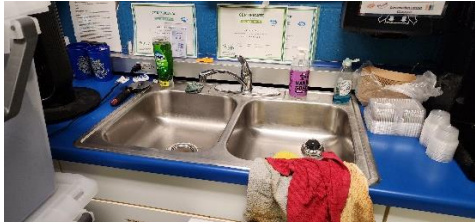
ID:	294-SHS-76	Location:	Concessions	
Photo:

Manufacturer:	Unknown	
		Description:		
		Sink		
		Result:	<1.0	ppb
		Date Sampled:	3/27/2024	By: JH
Recommended Action:

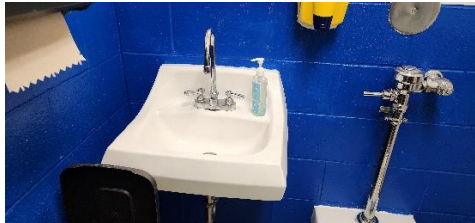
ID:	294-SHS-77	Location:	Officials Restroom	
Photo:

Manufacturer:	Unknown	
		Description:		
		Handwashing Sink		
		Result:	1.1	ppb
		Date Sampled:	3/27/2024	By: JH
Recommended Action:

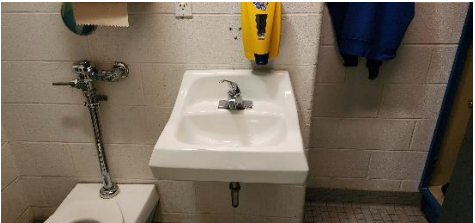
ID:	294-SHS-78	Location:	Men's locker Room	
Photo:

Manufacturer:	Unknown	
		Description:		
		Coach's office restroom handwashing sink		
		Result:	<1.0	ppb
		Date Sampled:	3/27/2024	By: JH
Recommended Action:

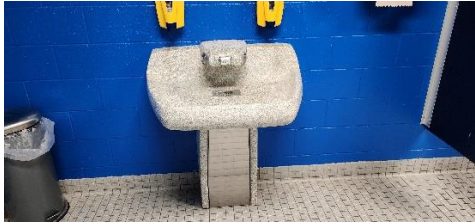
ID:	294-SHS-79	Location:	Men's Locker Room	
Photo:

Manufacturer:	Unknown	
		Description:		
		Left handwashing sink		
		Result:	1.3	ppb
		Date Sampled:	3/27/2024	By: JH
Recommended Action:

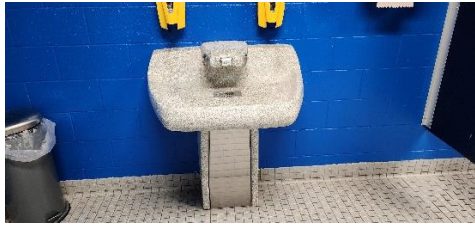
ID:	294-SHS-80	Location:	Men's Locker Room	
Photo:

Manufacturer:	Unknown	
		Description:		
		Middle handwashing sink		
		Result:	<1.0	ppb
		Date Sampled:	3/27/2024	By: JH
Recommended Action:

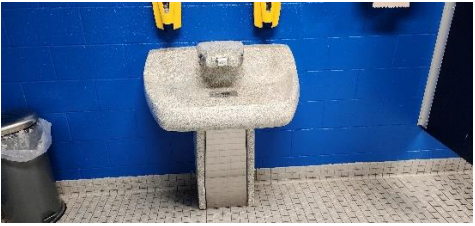
ID:	294-SHS-81	Location:	Men's Locker Room	
Photo:

Manufacturer:	Unknown	
		Description:		
		Right handwashing sink		
		Result:	1.1	ppb
		Date Sampled:	3/27/2024	By: JH
Recommended Action:

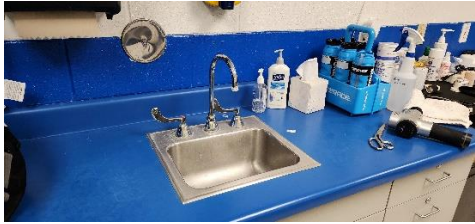
ID:	294-SHS-82	Location:	Athletic Trainer's Office	
Photo:

Manufacturer:	Chicago Faucet Co.	
		Description:		
		Sink		
		Result:	<1.0	ppb
		Date Sampled:	3/27/2024	By: JH
Recommended Action:

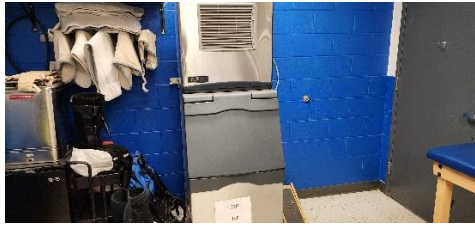
ID:	294-SHS-83	Location:	Athletic Trainer's Office	
Photo:

Manufacturer:	Scotsman	
		Description:		
		Ice Machine		
		Result:	<1.0	ppb
		Date Sampled:	3/27/2024	By: JH
Recommended Action:

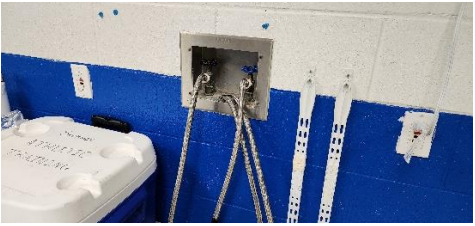
ID:	294-SHS-84	Location:	Athletic Trainer's Office	
Photo:

Manufacturer:	Unknown	
		Description:		
		Soaking Tub, Left faucet		
		Result:	1.4	ppb
		Date Sampled:	3/27/2024	By: JH
Recommended Action:

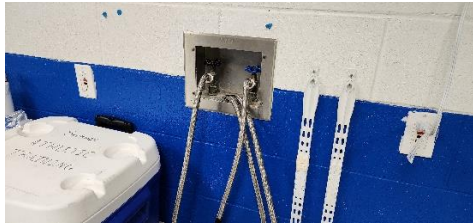
ID:	294-SHS-85	Location:	Athletic Trainer's Office	
Photo:

Manufacturer:	Unknown	
		Description:		
		Soaking Tub, Right faucet		
		Result:	<1.0	ppb
		Date Sampled:	3/27/2024	By: JH
Recommended Action:

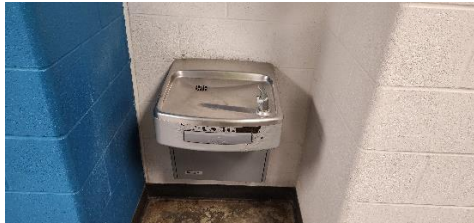
ID:	294-SHS-86	Location:	Women's Locker Room	
Photo:

Manufacturer:	Oasis	
		Description:		
		Drinking Fountain bubbler		
		Not functional at time of test		
		Result:	NA	ppb
		Date Sampled:	3/27/2024	By: JH
Recommended Action:		Sample Prior to Returning to Service

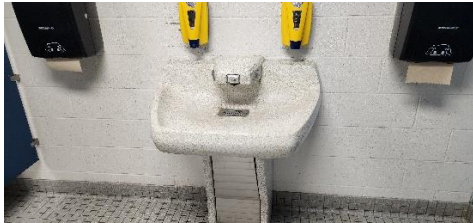
ID:	294-SHS-87	Location:	Women's Locker Room	
Photo:

Manufacturer:	Unknown	
		Description:		
		Left handwashing sink		
		Result:	1.9	ppb
		Date Sampled:	3/27/2024	By: JH
Recommended Action:

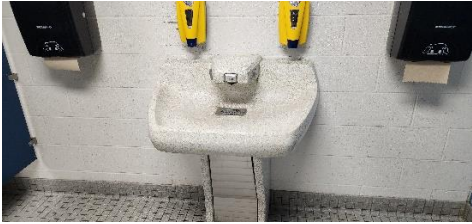
ID:	294-SHS-88	Location:	Women's Locker Room	
Photo:

Manufacturer:	Unknown	
		Description:		
		Left handwashing sink		
		Result:	<1.0	ppb
		Date Sampled:	3/27/2024	By: JH
Recommended Action:

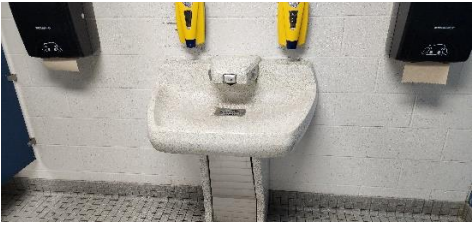
ID:	294-SHS-89	Location:	Women's Locker Room	
Photo:

Manufacturer:	Unknown	
		Description:		
		Left handwashing sink		
		Result:	4.4	ppb
		Date Sampled:	3/27/2024	By: JH
Recommended Action:

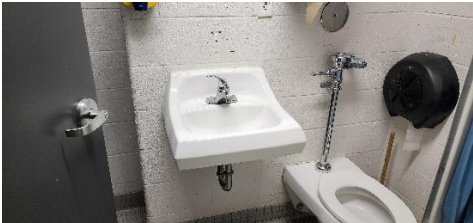
ID:	294-SHS-90	Location:	Women's Locker Room	
Photo:

Manufacturer:	Unknown	
		Description:		
		Coach's office restroom handwashing sink		
		Result:	<1.0	ppb
		Date Sampled:	3/27/2024	By: JH
Recommended Action:

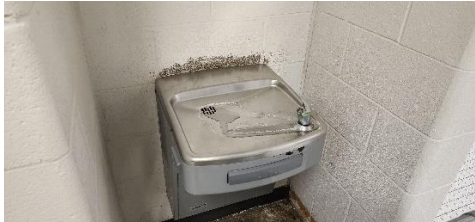
ID:	294-SHS-91	Location:	Women's Locker Room	
Photo:

Manufacturer:	Oasis	
		Description:		
		Drinking fountain bubbler		
		Not Functional at time of test.		
		Result:	NA	ppb
Date Sampled:	3/27/2024	By:	JH	
Recommended Action:		Remove from Service

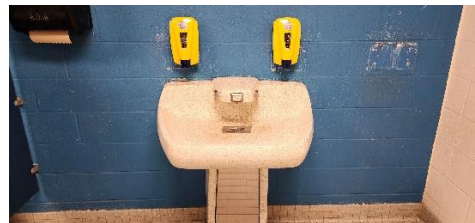
ID:	294-SHS-93	Location:	Women's Locker Room		
Photo:

Manufacturer:	Unknown		
		Description:			
		Middle handwashing sink			
		Result:	1.1	ppb	
		Date Sampled:	3/27/2024	By:	JH
Recommended Action:

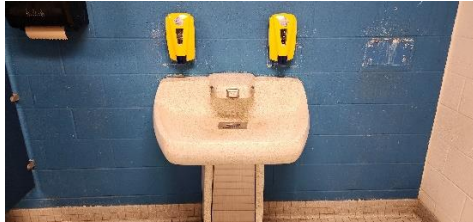
ID:	294-SHS-94	Location:	Women's Locker Room	
Photo:

Manufacturer:	Unknown	
		Description:		
		Right handwashing sink		
		Result:	2.2	ppb
		Date Sampled:	3/27/2024	By: JH
Recommended Action:

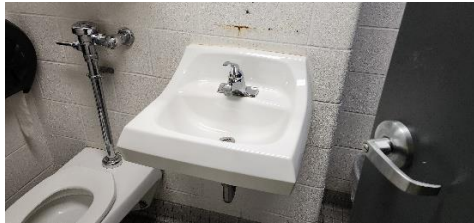
ID:	294-SHS-95	Location:	Women's Locker Room	
Photo:

Manufacturer:	Kohler	
		Description:		
		Coach's Office handwashing sink		
		Result:	<1.0	ppb
		Date Sampled:	3/27/2024	By: JH
Recommended Action:

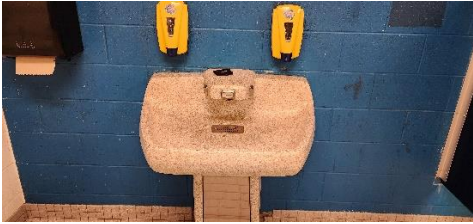
ID:	294-SHS-97	Location:	Men's Locker Room	
Photo:

Manufacturer:	Oasis	
		Description:		
		Left handwashing sink		
		Result:	2.3	ppb
		Date Sampled:	3/27/2024	By: JH
Recommended Action:

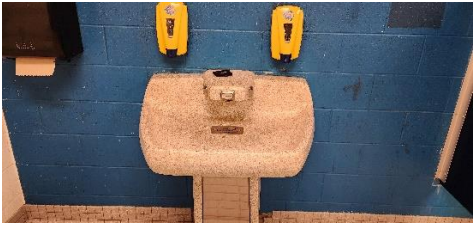
ID:	294-SHS-98	Location:	Men's Locker Room	
Photo:

Manufacturer:	Oasis	
		Description:		
		Middle handwashing sink		
		Result:	<1.0	ppb
		Date Sampled:	3/27/2024	By: JH
Recommended Action:

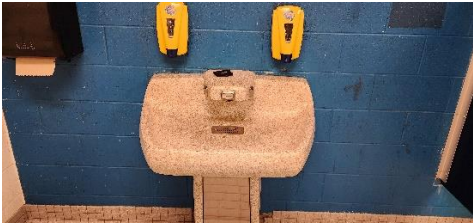
ID:	294-SHS-99	Location:	Men's Locker Room	
Photo:

Manufacturer:	Oasis	
		Description:		
		Right handwashing sink		
		Result:	1.7	ppb
		Date Sampled:	3/27/2024	By: JH
Recommended Action:

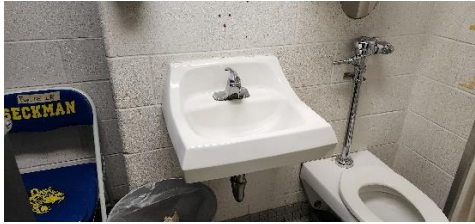
ID:	294-SHS-100	Location:	Men's Locker Room	
Photo:

Manufacturer:	Unknown	
		Description:		
		Coach's office restroom handwashing sink		
		Result:	<1.0	ppb
		Date Sampled:	3/27/2024	By: JH
Recommended Action:

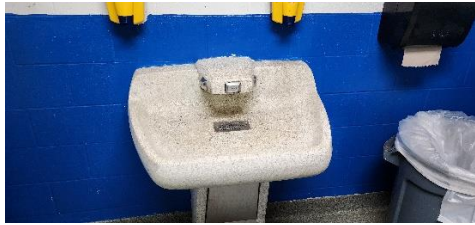
ID:	294-SHS-101	Location:	Men's Restroom	
Photo:

Manufacturer:	Unknown	
		Description:		
		Restroom by Door 16, left handwashing sink		
		Result:	<1.0	ppb
		Date Sampled:	3/27/2024	By: JH
Recommended Action:

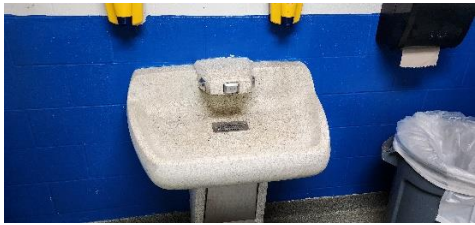
ID:	294-SHS-102	Location:	Men's Restroom	
Photo:

Manufacturer:	Unknown	
		Description:		
		Restroom by Door 16, middle handwashing sink		
		Result:	<1.0	ppb
		Date Sampled:	3/27/2024	By: JH
Recommended Action:

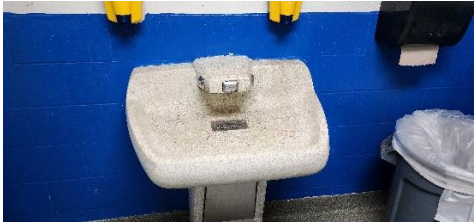
ID:	294-SHS-103	Location:	Men's Restroom	
Photo:

Manufacturer:	Unknown	
		Description:		
		Restroom by Door 16, right handwashing sink		
		Result:	<1.0	ppb
		Date Sampled:	3/27/2024	By: JH
Recommended Action:

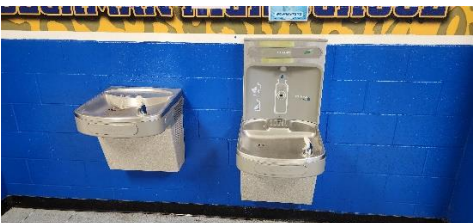
ID:	294-SHS-104	Location:	Hall by Door 16	
Photo:

Manufacturer:	Elkay	
		Description:		
		Left drinking fountain bubbler		
		Not strong enough flow to collect sample.		
		Result:	NA	ppb
		Date Sampled:	3/27/2024	By: JH
Recommended Action:		Replace Fixture/Unit and Resample

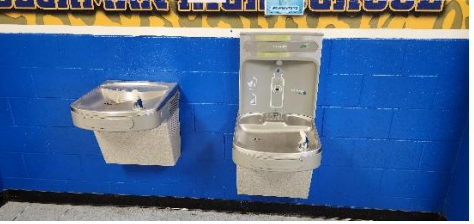
ID:	294-SHS-105	Location:	Hall by Door 16	
Photo:

Manufacturer:	Elkay	
		Description:		
		Right drinking fountain bubbler		
		Result:	<1.0	ppb
		Date Sampled:	3/27/2024	By: JH
Recommended Action:

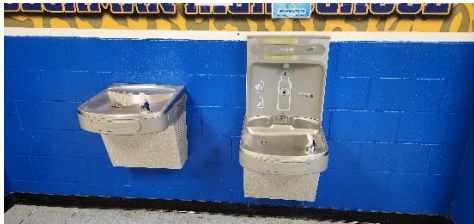
ID:	294-SHS-106	Location:	Hall by Door 16	
Photo:

Manufacturer:	Elkay	
		Description:		
		Drinking fountain bottle filler		
		Result:	<1.0	ppb
		Date Sampled:	3/27/2024	By: JH
Recommended Action:

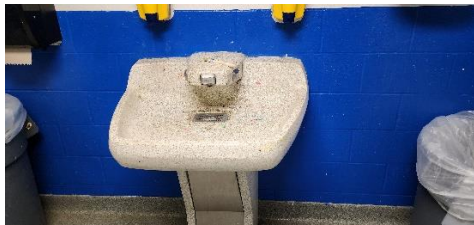
ID:	294-SHS-107	Location:	Women's Restroom	
Photo:

Manufacturer:	Unknown	
		Description:		
		By door 16, left handwashing sink		
		Result:	<1.0	ppb
		Date Sampled:	3/27/2024	By: JH
Recommended Action:

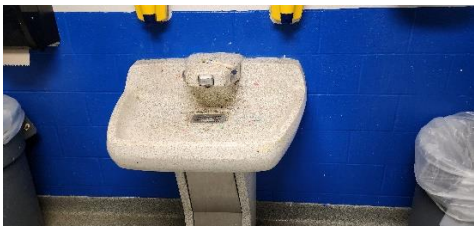
ID:	294-SHS-108	Location:	Women's Restroom	
Photo:

Manufacturer:	Unknown	
		Description:		
		By door 16, middle handwashing sink		
		Result:	<1.0	ppb
		Date Sampled:	3/27/2024	By: JH
Recommended Action:

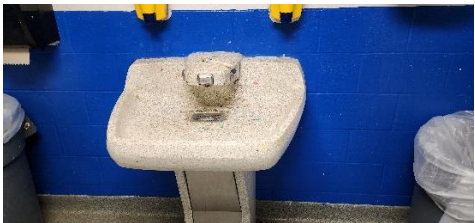
ID:	294-SHS-109	Location:	Women's Restroom	
Photo:

Manufacturer:	Unknown	
		Description:		
		By door 16, right handwashing sink		
		Result:	<1.0	ppb
		Date Sampled:	3/27/2024	By: JH
Recommended Action:

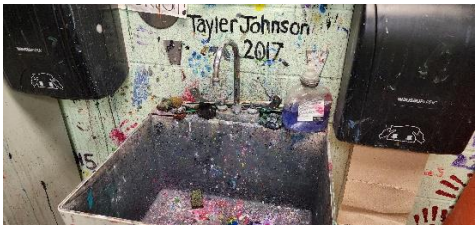
ID:	294-SHS-110	Location:	Room 001	
Photo:

Manufacturer:	Unknown	
		Description:		
		Utility Sink		
		Result:	<1.0	ppb
		Date Sampled:	3/27/2024	By: JH
Recommended Action:

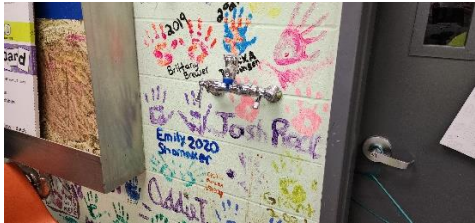
ID:	294-SHS-111	Location:	Room 001	
Photo:

Manufacturer:	Chicago Faucet Co.	
		Description:		
		Wall faucet		
		Result:	13.4	ppb
		Date Sampled:	3/27/2024	By: JH
Recommended Action:		Replace Fixture/Unit and Resample

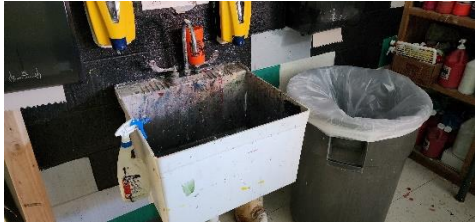
ID:	294-SHS-112	Location:	Room 003	
Photo:

Manufacturer:	Unknown	
		Description:		
		Utility Sink		
		Result:	<1.0	ppb
		Date Sampled:	3/27/2024	By: JH
Recommended Action:

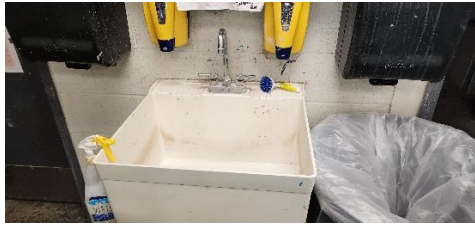
ID:	294-SHS-113	Location:	Room 007	
Photo:

Manufacturer:	Unknown	
		Description:		
		Utility Sink		
		Result:	<1.0	ppb
		Date Sampled:	3/27/2024	By: JH
Recommended Action:

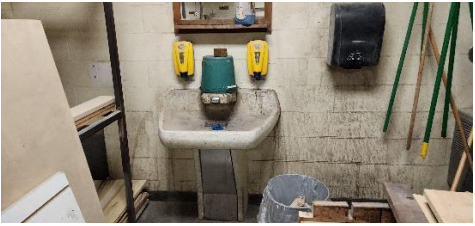
ID:	294-SHS-114	Location:	Room 008 (Wood Shop)	
Photo:

Manufacturer:	Unknown	
		Description:		
		Left handwashing sink		
		Result:	4.6	ppb
		Date Sampled:	3/27/2024	By: JH
Recommended Action:

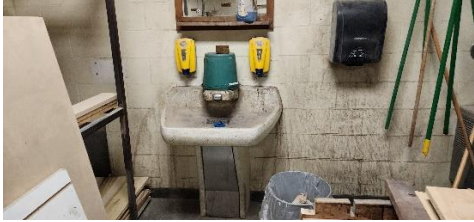
ID:	294-SHS-115	Location:	Room 008 (Wood Shop)	
Photo:

Manufacturer:	Unknown	
		Description:		
		Middle handwashing sink		
		Result:	1.1	ppb
		Date Sampled:	3/27/2024	By: JH
Recommended Action:

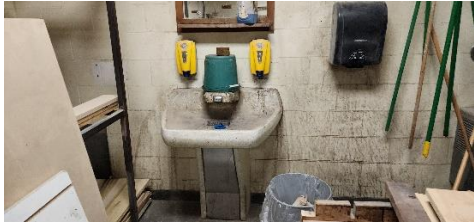
ID:	294-SHS-116	Location:	Room 008 (Wood Shop)	
Photo:

Manufacturer:	Unknown	
		Description:		
		Right handwashing sink		
		Result:	3	ppb
		Date Sampled:	3/27/2024	By: JH
Recommended Action:

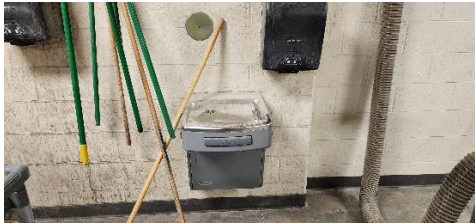
ID:	294-SHS-117	Location:	Room 008 (Wood Shop)	
Photo:

Manufacturer:	Oasis	
		Description:		
		Drinking fountain bubbler		
		Result:	<1.0	ppb
		Date Sampled:	3/27/2024	By: JH
Recommended Action:

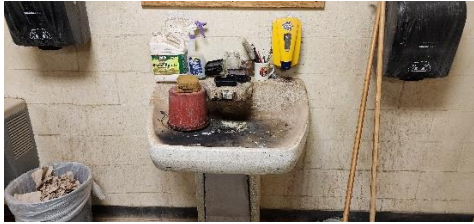
ID:	294-SHS-118	Location:	Room 006 (Wood Shop)		
Photo:

Manufacturer:	Unknown		
		Description:			
		Left handwashing sink			
		Result:	3.6	ppb	
		Date Sampled:	3/27/2024	By:	JH
Recommended Action:

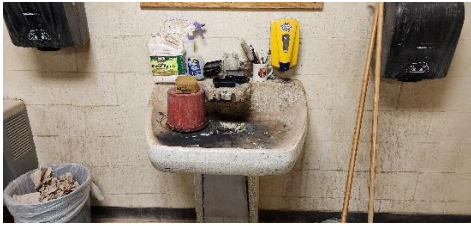
ID:	294-SHS-119	Location:	Room 006 (Wood Shop)		
Photo:

Manufacturer:	Unknown		
		Description:			
		Middle handwashing sink			
		Result:	1.5	ppb	
		Date Sampled:	3/27/2024	By:	JH
Recommended Action:

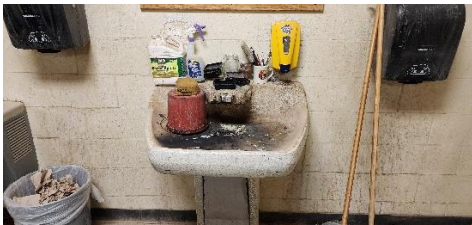
ID:	294-SHS-120	Location:	Room 006 (Wood Shop)		
Photo:

Manufacturer:	Unknown		
		Description:			
		Right handwashing sink			
		Result:	3.5	ppb	
		Date Sampled:	3/27/2024	By:	JH
Recommended Action:

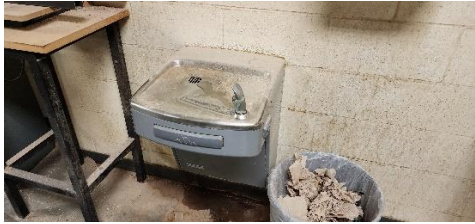
ID:	294-SHS-121	Location:	Room 006 (Wood Shop)	
Photo:

Manufacturer:	Oasis	
		Description:		
		Drinking fountain bubbler		
		Result:	1.1	ppb
		Date Sampled:	3/27/2024	By: JH
Recommended Action:

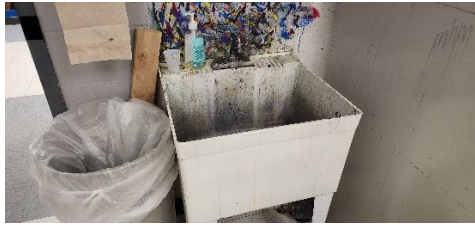
ID:	294-SHS-122	Location:	Room 002	
Photo:

Manufacturer:	Unknown	
		Description:		
		Utility Sink		
		Result:	<1.0	ppb
		Date Sampled:	3/27/2024	By: JH
Recommended Action:

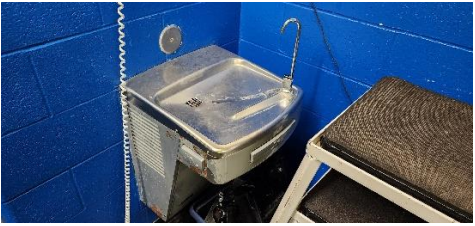
ID:	294-SHS-123	Location:	Room 012 (Weight RM)	
Photo:

Manufacturer:	Oasis	
		Description:		
		Drinking fountain bottle filler		
		Result:	<1.0	ppb
		Date Sampled:	3/27/2024	By: JH
Recommended Action:

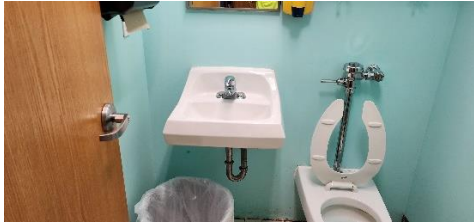
ID:	294-SHS-124	Location:	Room 200	
Photo:

Manufacturer:	Moen	
		Description:		
		Counselor's restroom handwashing sink		
		Result:	<1.0	ppb
		Date Sampled:	3/27/2024	By: JH
Recommended Action:

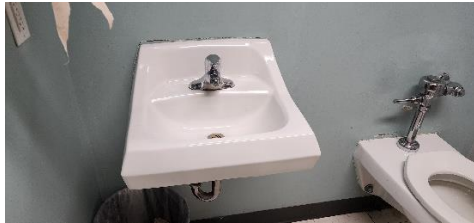
ID:	294-SHS-125	Location:	213-224 Hallway	
Photo:

Manufacturer:	Moen	
		Description:		
		Staff Lounge handwashing sink		
		Result:	<1.0	ppb
		Date Sampled:	3/27/2024	By: JH
Recommended Action:

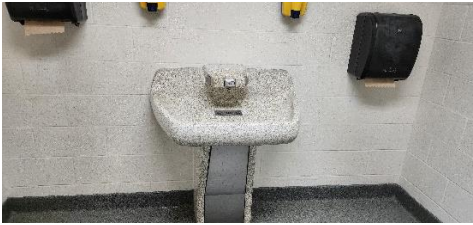
ID:	294-SHS-127	Location:	213-224 Hallway	
Photo:

Manufacturer:	Unknown	
		Description:		
		Men's Restroom, middle handwashing sink		
		Result:	<1.0	ppb
		Date Sampled:	3/27/2024	By: JH
Recommended Action:

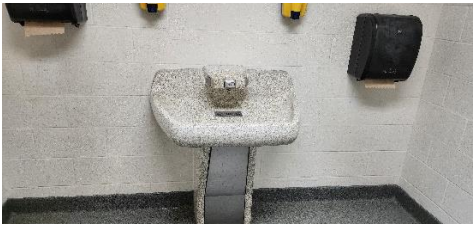
ID:	294-SHS-128	Location:	213-224 Hallway	
Photo:

Manufacturer:	Unknown	
		Description:		
		Men's Restroom, right handwashing sink		
		Result:	<1.0	ppb
		Date Sampled:	3/27/2024	By: JH
Recommended Action:

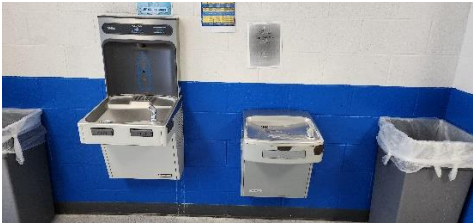
ID:	294-SHS-129	Location:	213-224 Hallway	
Photo:

Manufacturer:	Halsey Taylor	
		Description:		
		Left drinking fountain bubbler		
		Result:	<1.0	ppb
		Date Sampled:	3/27/2024	By: JH
Recommended Action:

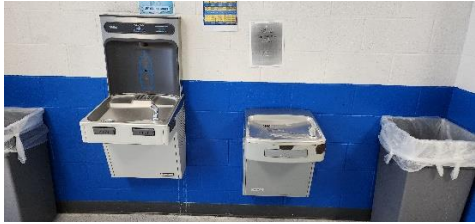
ID:	294-SHS-130	Location:	213-224 Hallway	
Photo:

Manufacturer:	Halsey Taylor	
		Description:		
		Left drinking fountain bottle filler		
		Result:	<1.0	ppb
		Date Sampled:	3/27/2024	By: JH
Recommended Action:

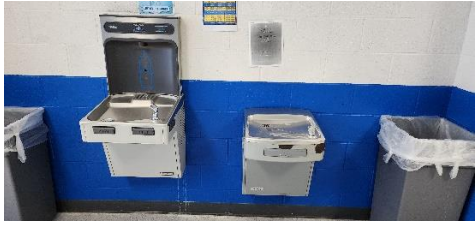
ID:	294-SHS-131	Location:	213-224 Hallway	
Photo:

Manufacturer:	Halsey Taylor	
		Description:		
		Right drinking fountain bubbler		
		Result:	<1.0	ppb
		Date Sampled:	3/27/2024	By: JH
Recommended Action:

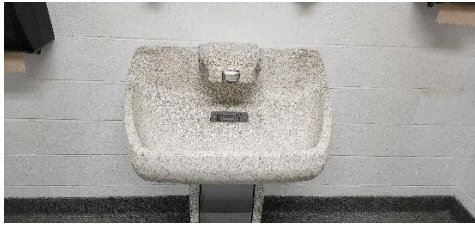
ID:	294-SHS-132	Location:	213-224 Hallway	
Photo:

Manufacturer:	Unknown	
		Description:		
		Women's restroom left handwashing sink		
		Result:	1	ppb
		Date Sampled:	3/27/2024	By: JH
Recommended Action:

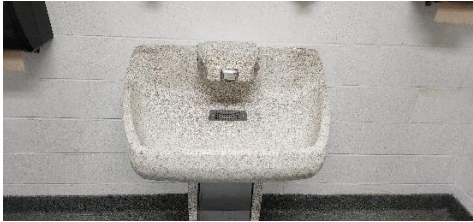
ID:	294-SHS-133	Location:	213-224 Hallway	
Photo:

Manufacturer:	Unknown	
		Description:		
		Women's restroom middle handwashing sink		
		Result:	<1.0	ppb
		Date Sampled:	3/27/2024	By: JH
Recommended Action:

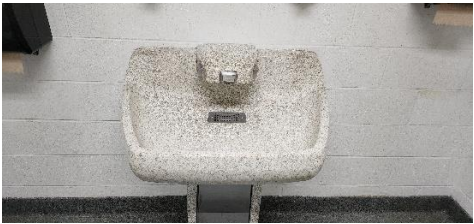
ID:	294-SHS-134	Location:	213-224 Hallway	
Photo:

Manufacturer:	Unknown	
		Description:		
		Women's restroom right handwashing sink		
		Result:	1.9	ppb
		Date Sampled:	3/27/2024	By: JH
Recommended Action:

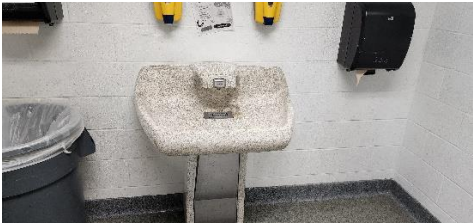
ID:	294-SHS-135	Location:	225-238 Hallway	
Photo:

Manufacturer:	Unknown	
		Description:		
		Women's restroom, left handwashing sink		
		Result:	1.5	ppb
		Date Sampled:	3/27/2024	By: JH
Recommended Action:

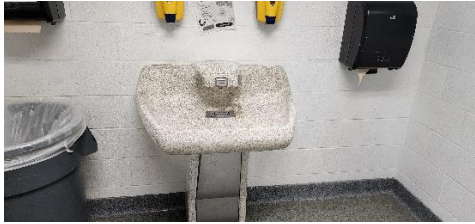
ID:	294-SHS-136	Location:	225-238 Hallway	
Photo:

Manufacturer:	Unknown	
		Description:		
		Women's restroom, left handwashing sink		
		Result:	3.2	ppb
		Date Sampled:	3/27/2024	By: JH
Recommended Action:

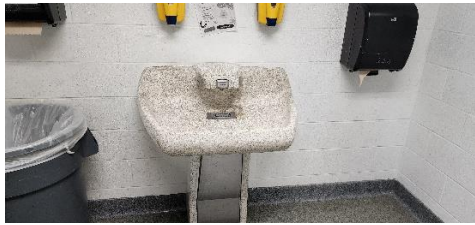
ID:	294-SHS-137	Location:	225-238 Hallway	
Photo:

Manufacturer:	Unknown	
		Description:		
		Women's restroom, left handwashing sink		
		Result:	2	ppb
		Date Sampled:	3/27/2024	By: JH
Recommended Action:

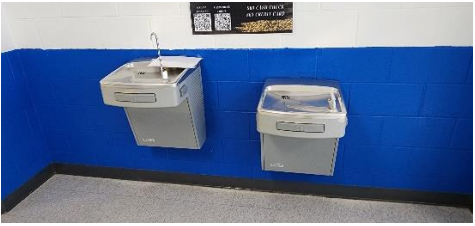
ID:	294-SHS-138	Location:	225-238 Hallway	
Photo:

Manufacturer:	Oasis	
		Description:		
		Drinking fountain bottle filler		
		Result:	<1.0	ppb
		Date Sampled:	3/27/2024	By: JH
Recommended Action:

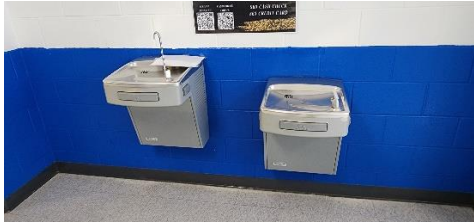
ID:	294-SHS-139	Location:	225-238 Hallway		
Photo:

Manufacturer:	Oasis		
		Description:			
		Drinking fountain bubbler			
		Result:	<1.0	ppb	
Recommended Action:		Date Sampled:	3/27/2024	By:	JH

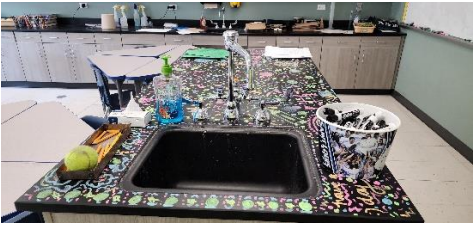
ID:	294-SHS-143	Location:	Room 225	
Photo:

Manufacturer:	Chicago Faucet Co.	
		Description:		
		Left side, teacher island		
		Result:	1.2	ppb
		Date Sampled:	3/27/2024	By: JH
Recommended Action:

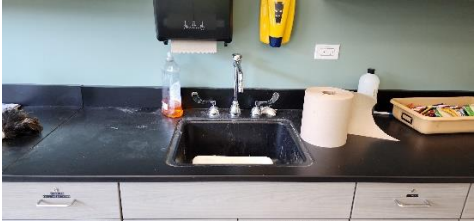
ID:	294-SHS-144	Location:	Room 225	
Photo:

Manufacturer:	Chicago Faucet Co.	
		Description:		
		Right wall, left side, left faucet.		
		Result:	1.6	ppb
		Date Sampled:	3/27/2024	By: JH
Recommended Action:

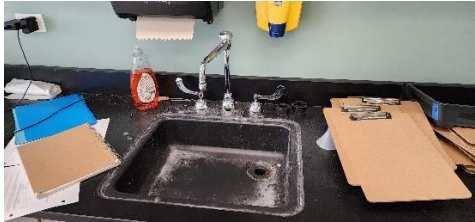
ID:	294-SHS-145	Location:	Room 225	
Photo:

Manufacturer:	Chicago Faucet Co.	
		Description:		
		Right Wall, Left side right faucet		
		Result:	1.3	ppb
		Date Sampled:	3/27/2024	By: JH
Recommended Action:

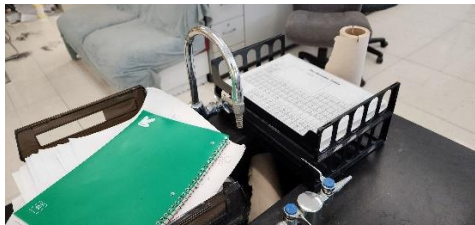
Manufacturer:	Unknown	
		Description:		
		Teacher Island, left faucet		
		Result:	89.6	ppb
		Date Sampled:	3/27/2024	By: JH
Recommended Action:		Mark as nonpotable water/Not drinking water

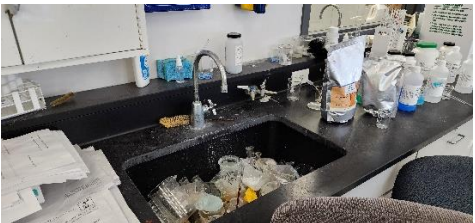
ID:	294-SHS-147	Location:	Room 227	
Photo:

Manufacturer:	Unknown	
		Description:		
		Left wall, left side, left faucet.		
		Result:	37.2	ppb
		Date Sampled:	3/27/2024	By: JH
Recommended Action:		Mark as nonpotable water/Not drinking water

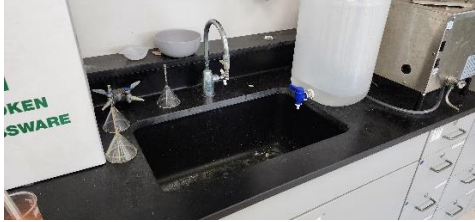
ID:	294-SHS-148	Location:	Room 227	
Photo:

Manufacturer:	Unknown	
		Description:		
		Left wall, left side, right faucet.		
		Result:	85	ppb
		Date Sampled:	3/27/2024	By: JH
Recommended Action:		Mark as nonpotable water/Not drinking water

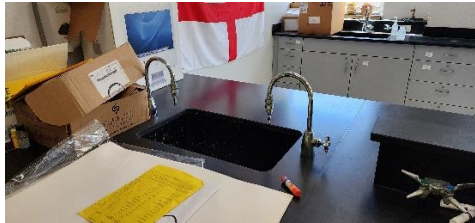
ID:	294-SHS-149	Location:	Room 227	
Photo:

Manufacturer:	Unknown	
		Description:		
		Left Center Island sink, left sink, left faucet		
		Result:	429	ppb
		Date Sampled:	3/27/2024	By: JH
Recommended Action:		Mark as nonpotable water/Not drinking water

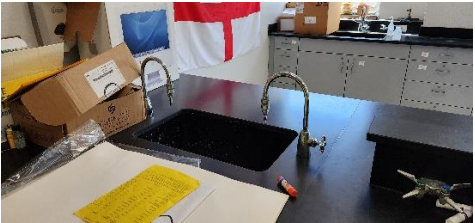
ID:	294-SHS-150	Location:	Room 227	
Photo:

Manufacturer:	Unknown	
		Description:		
		Left Center Island sink, left sink, right faucet		
		Result:	63.2	ppb
		Date Sampled:	3/27/2024	By: JH
Recommended Action:		Mark as nonpotable water/Not drinking water

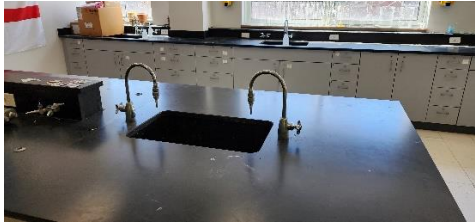
ID:	294-SHS-151	Location:	Room 227		
Photo:

Manufacturer:	Unknown		
		Description:			
		Left Center Island sink, right sink, left faucet			
		Result:	73.8	ppb	
		Date Sampled:	3/27/2024	By:	JH
Recommended Action:		Mark as nonpotable water/Not drinking water

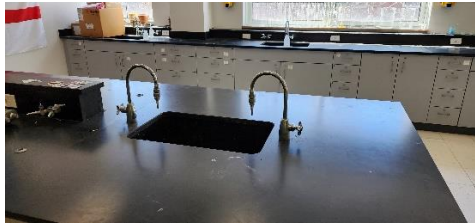
ID:	294-SHS-152	Location:	Room 227		
Photo:

Manufacturer:	Unknown		
		Description:			
		Left Center Island sink, right sink, right faucet			
		Result:	60.4	ppb	
		Date Sampled:	3/27/2024	By:	JH
Recommended Action:		Mark as nonpotable water/Not drinking water

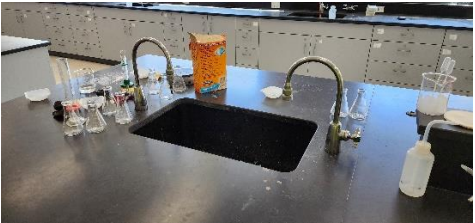
ID:	294-SHS-153	Location:	Room 227		
Photo:

Manufacturer:	Unknown		
		Description:			
		Right center island, left sink, left faucet			
		Result:	44.6	ppb	
		Date Sampled:	3/27/2024	By:	JH
Recommended Action:		Mark as nonpotable water/Not drinking water
