May 10, 2024

RE: Drinking Water Sampling – Seckman Senior High School
2800 Seckman Rd, Imperial, MO 63052
Project Number: 923294

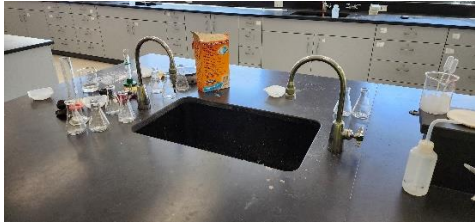
ID:	294-SHS-154	Location:	Room 227	
Photo:

Manufacturer:	Unknown	
		Description:		
		Right center island, left sink, right faucet		
		Result:	42.1	ppb
		Date Sampled:	3/27/2024	By: JH
Recommended Action:		Mark as nonpotable water/Not drinking water

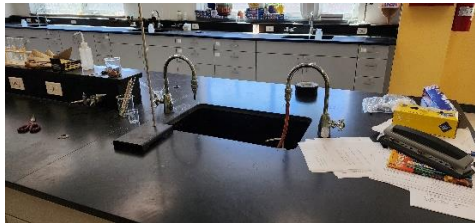
ID:	294-SHS-155	Location:	Room 227	
Photo:

Manufacturer:	Unknown	
		Description:		
		Right center island, right sink, left faucet		
		Result:	38	ppb
		Date Sampled:	3/27/2024	By: JH
Recommended Action:		Mark as nonpotable water/Not drinking water

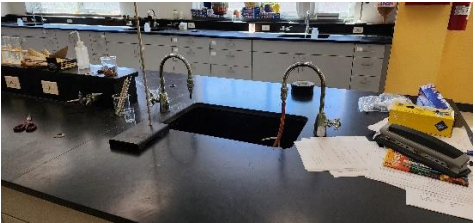
ID:	294-SHS-156	Location:	Room 227	
Photo:

Manufacturer:	Unknown	
		Description:		
		Right center island, right sink, right faucet		
		Result:	36.3	ppb
		Date Sampled:	3/27/2024	By: JH
Recommended Action:		Mark as nonpotable water/Not drinking water

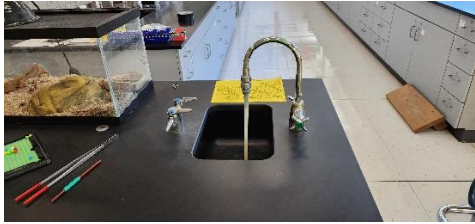
Manufacturer:	Unknown	
		Description:		
		Teacher island, right faucet.		
		Result:	57.2	ppb
		Date Sampled:	3/27/2024	By: JH
Recommended Action:		Mark as nonpotable water/Not drinking water

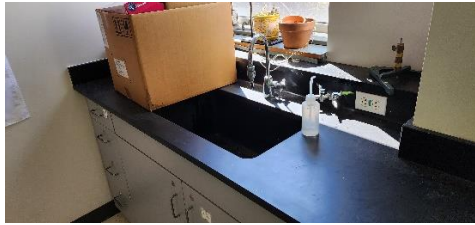
Manufacturer:	Unknown	
		Description:		
		Window wall, left sink		
		Result:	395	ppb
		Date Sampled:	3/27/2024	By: JH
Recommended Action:		Mark as nonpotable water/Not drinking water

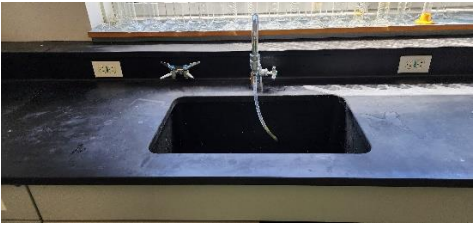
Manufacturer:	Unknown	
		Description:		
		Window wall, left middle sink		
		Result:	47.3	ppb
		Date Sampled:	3/27/2024	By: JH
Recommended Action:		Mark as nonpotable water/Not drinking water

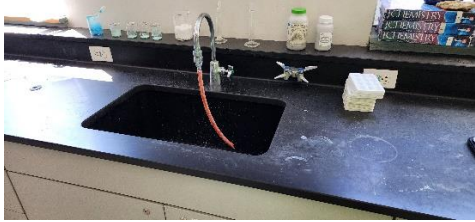
ID:	294-SHS-160	Location:	Room 227	
Photo:

Manufacturer:	Unknown	
		Description:		
		Window wall, right middle sink		
		Result:	66.9	ppb
		Date Sampled:	3/27/2024	By: JH
Recommended Action:		Mark as nonpotable water/Not drinking water

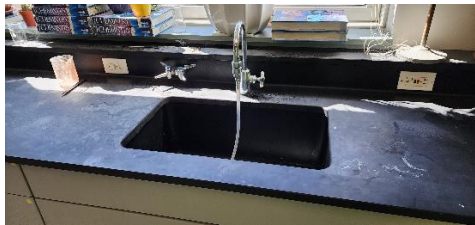
Manufacturer:	Unknown	
		Description:		
		Window wall, right sink		
		Result:	28.7	ppb
		Date Sampled:	3/27/2024	By: JH
Recommended Action:		Mark as nonpotable water/Not drinking water

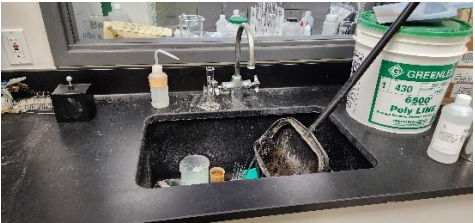
ID:	294-SHS-162	Location:	Room 227	
Photo:

Manufacturer:	Unknown	
		Description:		
		Storage sink		
		Result:	72.8	ppb
		Date Sampled:	3/27/2024	By: JH
Recommended Action:		Mark as nonpotable water/Not drinking water

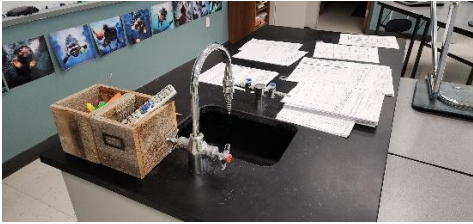
Manufacturer:	Unknown	
		Description:		
		Island with single sink		
		Result:	89.1	ppb
		Date Sampled:	3/27/2024	By: JH
Recommended Action:		Mark as nonpotable water/Not drinking water

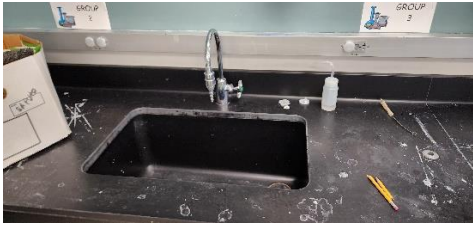
Manufacturer:	Water Saver Faucet	
		Description:		
		Back wall, left sink		
		Result:	35.2	ppb
		Date Sampled:	3/27/2024	By: JH
Recommended Action:		Mark as nonpotable water/Not drinking water

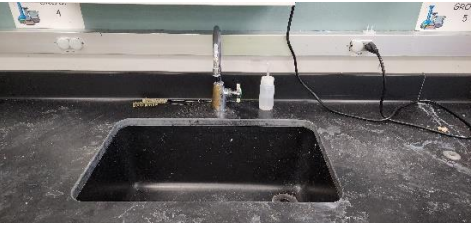
Manufacturer:	Water Saver Faucet	
		Description:		
		back wall, center sink		
		Result:	20.8	ppb
		Date Sampled:	3/27/2024	By: JH
Recommended Action:		Mark as nonpotable water/Not drinking water

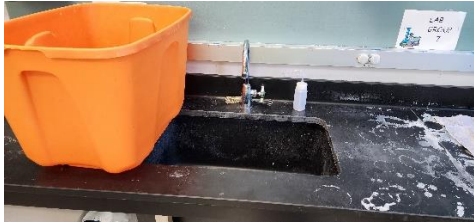
Manufacturer:	Water Saver Faucet	
		Description:		
		back wall, right sink		
		Result:	21.4	ppb
		Date Sampled:	3/27/2024	By: JH
Recommended Action:		Mark as nonpotable water/Not drinking water

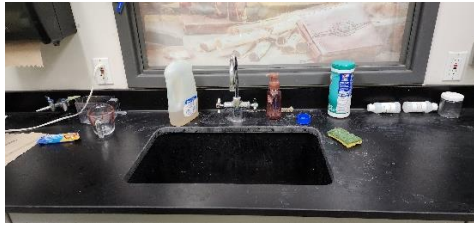
Manufacturer:	Water Saver Faucet	
		Description:		
		Left side, right faucet		
		Result:	17.2	ppb
		Date Sampled:	3/27/2024	By: JH
Recommended Action:		Mark as nonpotable water/Not drinking water

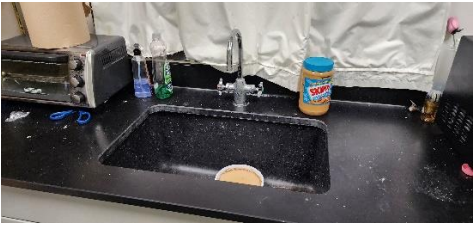
Manufacturer:	Water Saver Faucet	
		Description:		
		Left side, left faucet		
		Result:	18.9	ppb
		Date Sampled:	3/27/2024	By: JH
Recommended Action:		Mark as nonpotable water/Not drinking water

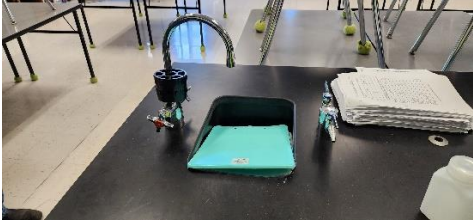
ID:	294-SHS-169	Location:	Room 231	
Photo:

Manufacturer:	Water Saver Faucet	
		Description:		
		Teacher Island, left sink		
		Not functional at time of test.		
		Result:	NA	ppb
Date Sampled:	3/27/2024	By:	JH	
Recommended Action:		Mark as nonpotable water/Not drinking water

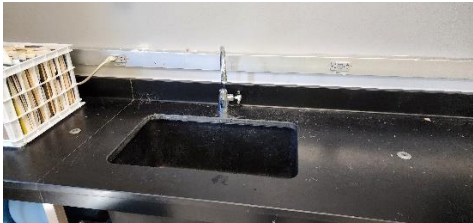
ID:	294-SHS-170	Location:	Room 231		
Photo:

Manufacturer:	Water Saver Faucet Co.		
		Description:			
		Back wall, left side left faucet			
		Result:	27.2	ppb	
		Date Sampled:	3/27/2024	By:	JH
Recommended Action:		Mark as nonpotable water/Not drinking water

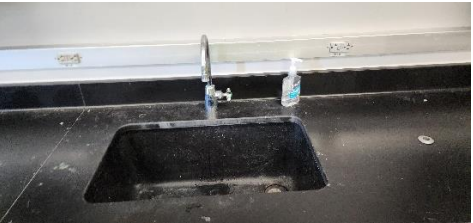
ID:	294-SHS-171	Location:	Room 231		
Photo:

Manufacturer:	Water Saver Faucet Co.		
		Description:			
		Back Wall, left side, middle faucet			
		Result:	29.3	ppb	
		Date Sampled:	3/27/2024	By:	JH
Recommended Action:		Mark as nonpotable water/Not drinking water

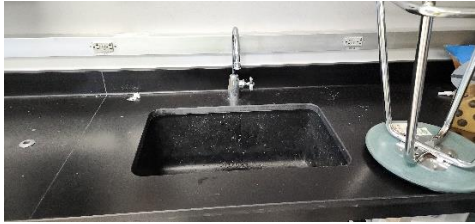
Manufacturer:	Water Saver Faucet Co.	
		Description:		
		Back wall, left side, right faucet		
		Result:	33.8	ppb
		Date Sampled:	3/27/2024	By: JH
Recommended Action:		Mark as nonpotable water/Not drinking water

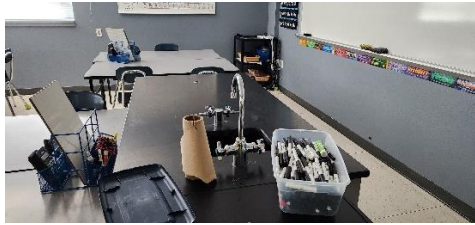
Manufacturer:	Unknown	
		Description:		
		Teacher Island, left side sink		
		Result:	13.5	ppb
		Date Sampled:	3/27/2024	By: JH
Recommended Action:		Mark as nonpotable water/Not drinking water

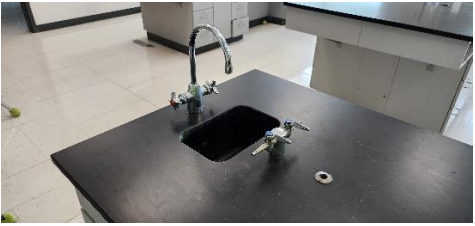
Manufacturer:	Water Saver Faucet Co.	
		Description:		
		Teacher Island, left side, left sink facing tables		
		Result:	11.7	ppb
		Date Sampled:	3/27/2024	By: JH
Recommended Action:		Mark as nonpotable water/Not drinking water

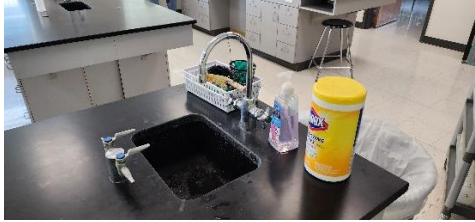
ID:	294-SHS-175	Location:	Room 236	
Photo:

Manufacturer:	Water Saver Faucet Co.	
		Description:		
		Teacher Island, left side, right sink		
		Result:	16.9	ppb
		Date Sampled:	3/27/2024	By: JH
Recommended Action:		Mark as nonpotable water/Not drinking water

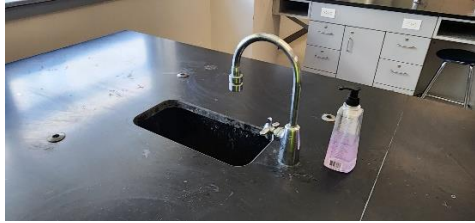
ID:	294-SHS-176	Location:	Room 236	
Photo:

Manufacturer:	Water Saver Faucet Co.	
		Description:		
		Lab Station 8, Table 1 sink		
		Result:	19.3	ppb
		Date Sampled:	3/27/2024	By: JH
Recommended Action:		Mark as nonpotable water/Not drinking water

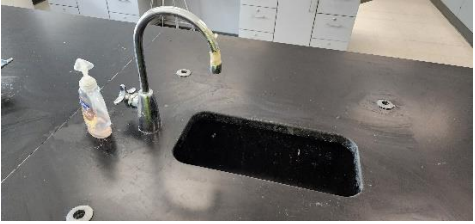
Manufacturer:	Water Saver Faucet Co.	
		Description:		
		Lab Station 7, table 1 sink		
		Result:	19	ppb
		Date Sampled:	3/27/2024	By: JH
Recommended Action:		Mark as nonpotable water/Not drinking water

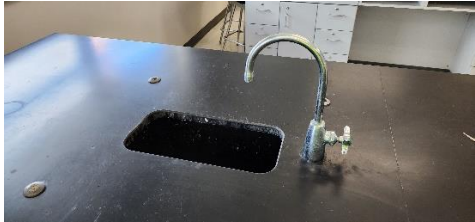
ID:	294-SHS-178	Location:	Room 236	
Photo:

Manufacturer:	Water Saver Faucet Co.	
		Description:		
		Lab station 6, Table 2 sink		
		Result:	21.3	ppb
		Date Sampled:	3/27/2024	By: JH
Recommended Action:		Mark as nonpotable water/Not drinking water

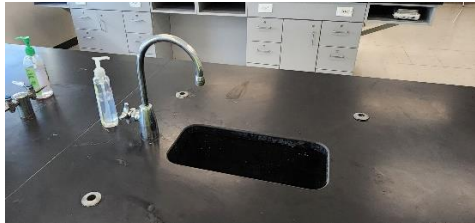
ID:	294-SHS-179	Location:	Room 236	
Photo:

Manufacturer:	Water Saver Faucet Co.	
		Description:		
		Lab Station 5, Table 2 sink		
		Result:	18.9	ppb
		Date Sampled:	3/27/2024	By: JH
Recommended Action:		Mark as nonpotable water/Not drinking water

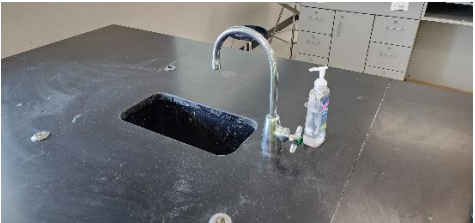
ID:	294-SHS-180	Location:	Room 236	
Photo:

Manufacturer:	Water Saver Faucet Co.	
		Description:		
		Lab station 4, table 3 sink		
		Result:	25.8	ppb
		Date Sampled:	3/27/2024	By: JH
Recommended Action:		Mark as nonpotable water/Not drinking water

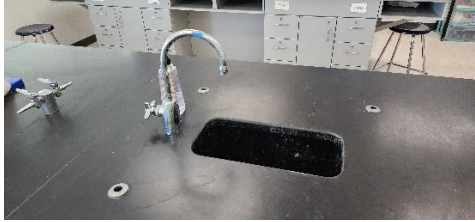
ID:	294-SHS-181	Location:	Room 236	
Photo:

Manufacturer:	Water Saver Faucet Co.	
		Description:		
		Lab Station 3, table 3		
		Result:	14.9	ppb
		Date Sampled:	3/27/2024	By: JH
Recommended Action:		Mark as nonpotable water/Not drinking water

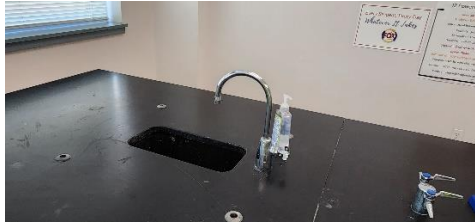
ID:	294-SHS-182	Location:	Room 236	
Photo:

Manufacturer:	Water Saver Faucet Co.	
		Description:		
		Lab station 2, table 4		
		Result:	15.8	ppb
		Date Sampled:	3/27/2024	By: JH
Recommended Action:		Mark as nonpotable water/Not drinking water

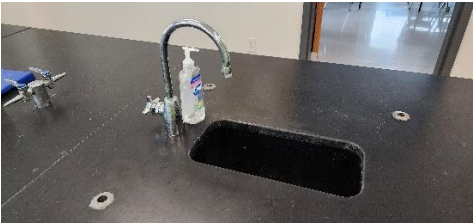
ID:	294-SHS-183	Location:	Room 236	
Photo:

Manufacturer:	Water Saver Faucet Co.	
		Description:		
		Table 4, Lab station 1		
		Result:	19.1	ppb
		Date Sampled:	3/27/2024	By: JH
Recommended Action:		Mark as nonpotable water/Not drinking water

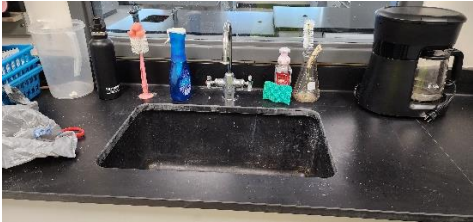
ID:	294-SHS-184	Location:	Room 236 Storage	
Photo:

Manufacturer:	Water Saver Faucet Co.	
		Description:		
		Left side sink		
		Result:	11	ppb
		Date Sampled:	3/27/2024	By: JH
Recommended Action:		Mark as nonpotable water/Not drinking water

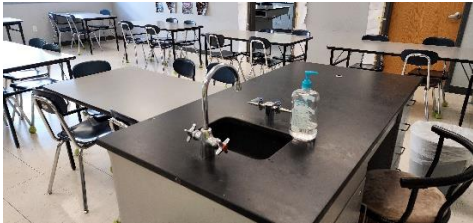
ID:	294-SHS-185	Location:	Room 234	
Photo:

Manufacturer:	Water Saver Faucet Co.	
		Description:		
		Teacher's Island, left side sink		
		Result:	7	ppb
		Date Sampled:	3/27/2024	By: JH
Recommended Action:		Mark as nonpotable water/Not drinking water

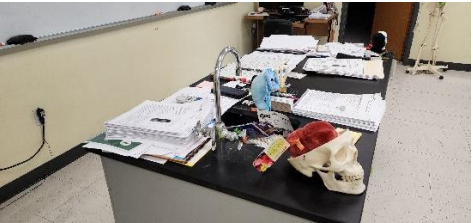
ID:	294-SHS-186	Location:	Room 232	
Photo:

Manufacturer:	Water Saver Faucet co.	
		Description:		
		Teacher's Island sink		
		Not Functional at time of test.		
		Result:	NF	ppb
		Date Sampled:	3/27/2024	By: JH
Recommended Action:		Mark as nonpotable water/Not drinking water

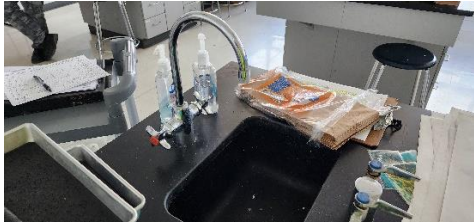
Manufacturer:	Water Saver Faucet Co.	
		Description:		
		Teacher Island, facing tables, left sink		
		Result:	18.9	ppb
		Date Sampled:	3/27/2024	By: JH
Recommended Action:		Mark as nonpotable water/Not drinking water

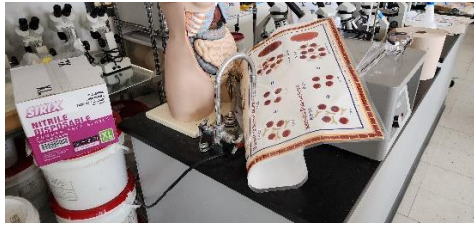
Manufacturer:	Water Saver Faucet Co.	
		Description:		
		Teacher Island, facing tables, right sink		
		Result:	158	ppb
		Date Sampled:	3/27/2024	By: JH
Recommended Action:		Mark as nonpotable water/Not drinking water

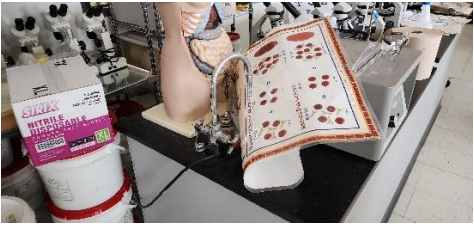
Manufacturer:	Water Saver Faucet co.	
		Description:		
		Table 1, station 2 sink		
		Result:	30.6	ppb
		Date Sampled:	3/27/2024	By: JH
Recommended Action:		Mark as nonpotable water/Not drinking water

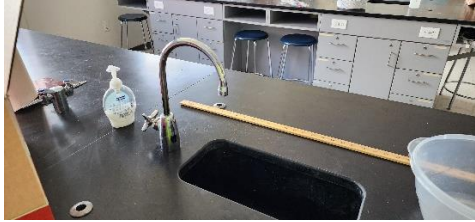
ID:	294-SHS-190	Location:	Room 230
Photo:

Manufacturer:	Water Saver Faucet Co.
		Description:	
		Table 1, Station 1 sink	
		Result:	20.1
		Date Sampled:	3/27/2024 By: JH
Recommended Action:		Mark as nonpotable water/Not drinking water

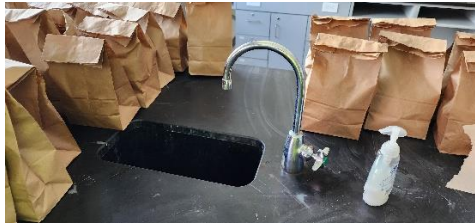
ID:	294-SHS-191	Location:	Room 230
Photo:

Manufacturer:	Water Saver Faucet Co.
		Description:	
		Table 2, station 4 sink	
		Result:	27.5
		Date Sampled:	3/27/2024 By: JH
Recommended Action:		Mark as nonpotable water/Not drinking water

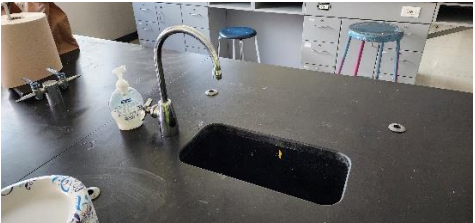
ID:	294-SHS-192	Location:	Room 230
Photo:

Manufacturer:	Water Saver Faucet Co.
		Description:	
		Table 2, Station 3 sink	
		Result:	27.4
		Date Sampled:	3/27/2024 By: JH
Recommended Action:		Mark as nonpotable water/Not drinking water

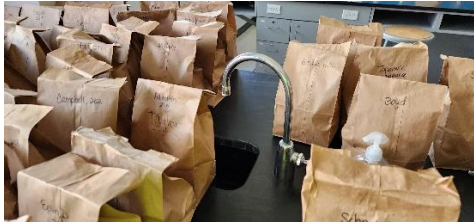
Manufacturer:	Water Saver Faucet Co.	
		Description:		
		Table 3, station 6 sink		
		Result:	16.4	ppb
		Date Sampled:	3/27/2024	By: JH
Recommended Action:		Mark as nonpotable water/Not drinking water

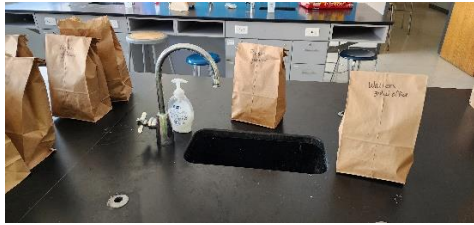
Manufacturer:	Water Saver Faucet Co.	
		Description:		
		Table 3, station 5 sink		
		Result:	10.5	ppb
		Date Sampled:	3/27/2024	By: JH
Recommended Action:		Mark as nonpotable water/Not drinking water

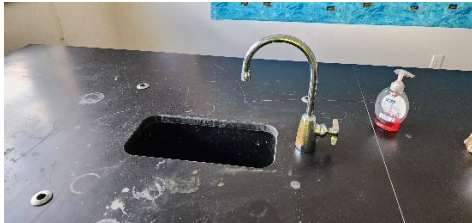
ID:	294-SHS-195	Location:	Room 230	
Photo:

Manufacturer:	Water Saver Faucet Co.	
		Description:		
		Table 4, station 8 sink		
		Result:	27.2	ppb
		Date Sampled:	3/27/2024	By: JH
Recommended Action:		Mark as nonpotable water/Not drinking water

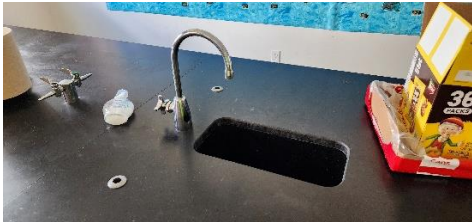
ID:	294-SHS-196	Location:	Room 230	
Photo:

Manufacturer:	Water Saver Faucet Co.	
		Description:		
		Table 4, station 7 left side sink		
		Result:	25.8	ppb
		Date Sampled:	3/27/2024	By: JH
Recommended Action:		Mark as nonpotable water/Not drinking water

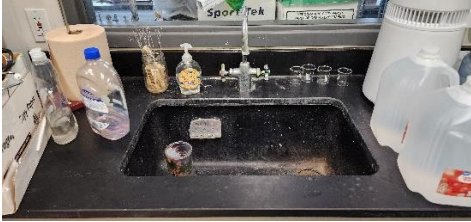
ID:	294-SHS-197	Location:	Room 230/Storage 232	
Photo:

Manufacturer:	Water Saver Faucet Co.	
		Description:		
		Table 4, station 7 right side sink		
		Result:	11.2	ppb
		Date Sampled:	3/27/2024	By: JH
Recommended Action:		Mark as nonpotable water/Not drinking water

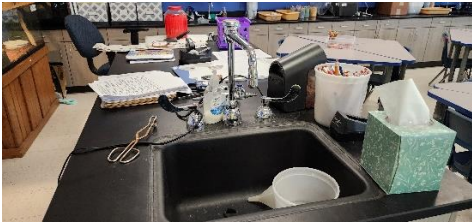
ID:	294-SHS-198	Location:	Room 228	
Photo:

Manufacturer:	Chicago Faucet Co.	
		Description:		
		Teacher Island, left side sink		
		Result:	9.2	ppb
		Date Sampled:	3/27/2024	By: JH
Recommended Action:		Mark as nonpotable water/Not drinking water

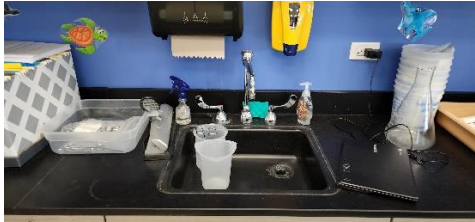
ID:	294-SHS-199	Location:	Room 228	
Photo:

Manufacturer:	Chicago Faucet Co.	
		Description:		
		Left wall, left side left sink		
		Result:	<1.0	ppb
		Date Sampled:	3/27/2024	By: JH
Recommended Action:

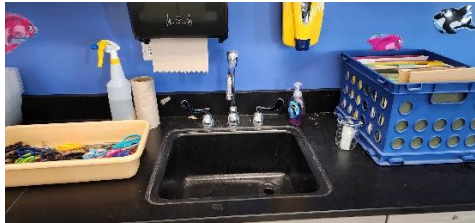
ID:	294-SHS-200	Location:	Room 228	
Photo:

Manufacturer:	Chicago Faucet Co.	
		Description:		
		Left wall, left side, right sink		
		Result:	1.7	ppb
		Date Sampled:	3/27/2024	By: JH
Recommended Action:

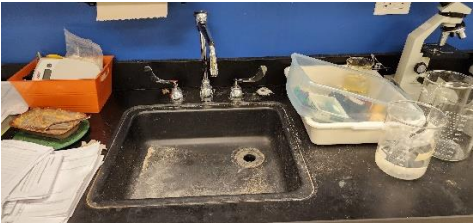
ID:	294-SHS-201	Location:	Room 226	
Photo:

Manufacturer:	Chicago Faucet co.	
		Description:		
		Left wall, left side, left sink		
		Result:	<1.0	ppb
		Date Sampled:	3/27/2024	By: JH
Recommended Action:

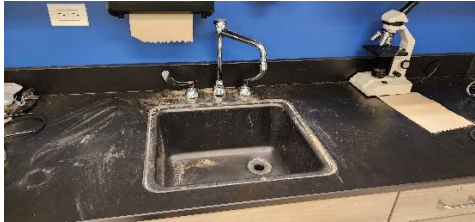
ID:	294-SHS-202	Location:	Room 226	
Photo:

Manufacturer:	Chicago Faucet co.	
		Description:		
		Left wall, left side, right sink		
		Result:	<1.0	ppb
		Date Sampled:	3/27/2024	By: JH
Recommended Action:

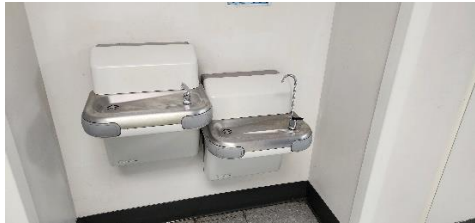
ID:	294-SHS-203	Location:	Hall by elevator	
Photo:

Manufacturer:	Halsey Taylor	
		Description:		
		Left drinking fountain bubbler		
		Result:	<1.0	ppb
		Date Sampled:	3/27/2024	By: JH
Recommended Action:

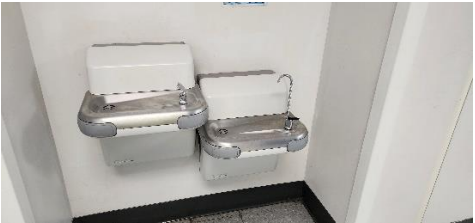
ID:	294-SHS-204	Location:	Hall by Elevator	
Photo:

Manufacturer:	Halsey Taylor	
		Description:		
		Right drinking fountain bottle filler		
		Result:	<1.0	ppb
		Date Sampled:	3/27/2024	By: JH
Recommended Action:

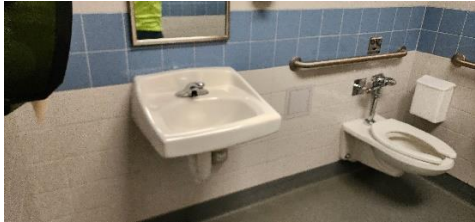
ID:	294-SHS-205	Location:	Staff Restroom	
Photo:

Manufacturer:	Sloan	
		Description:		
		Handwashing Sink		
		Result:	<1.0	ppb
		Date Sampled:	3/27/2024	By: JH
Recommended Action:

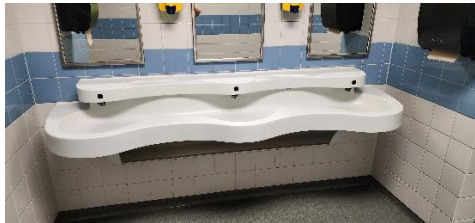
ID:	294-SHS-206	Location:	Hall by Elevator	
Photo:

Manufacturer:	Unknown	
		Description:		
		Boy's Restroom, Left handwashing sink		
		Result:	<1.0	ppb
		Date Sampled:	3/27/2024	By: JH
Recommended Action:

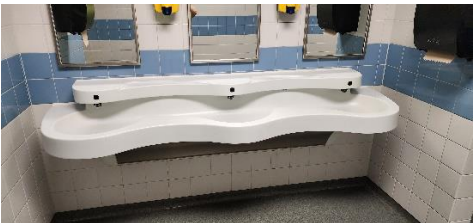
ID:	294-SHS-207	Location:	Hall by Elevator	
Photo:

Manufacturer:	Unknown	
		Description:		
		Boy's Restroom, middle handwashing sink		
		Result:	<1.0	ppb
		Date Sampled:	3/27/2024	By: JH
Recommended Action:

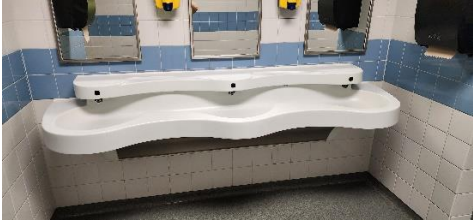
ID:	294-SHS-208	Location:	Hall by Elevator	
Photo:

Manufacturer:	Unknown	
		Description:		
		Boy's Restroom, right handwashing sink		
		Result:	<1.0	ppb
		Date Sampled:	3/27/2024	By: JH
Recommended Action:

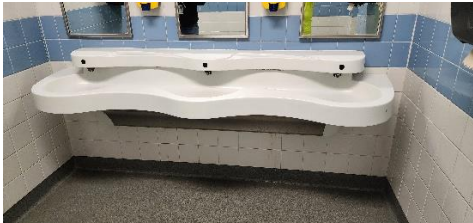
ID:	294-SHS-209	Location:	Hall by Elevator	
Photo:

Manufacturer:	Unknown	
		Description:		
		Girl's Restroom left handwashing sink		
		Result:	<1.0	ppb
		Date Sampled:	3/27/2024	By: JH
Recommended Action:

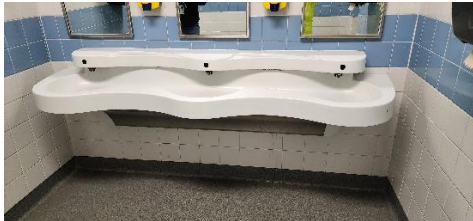
ID:	294-SHS-210	Location:	Hall by Elevator	
Photo:

Manufacturer:	Unknown	
		Description:		
		Girl's Restroom middle handwashing sink		
		Result:	<1.0	ppb
		Date Sampled:	3/27/2024	By: JH
Recommended Action:

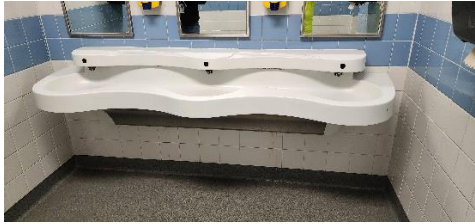
ID:	294-SHS-211	Location:	Hall by Elevator	
Photo:

Manufacturer:	Unknown	
		Description:		
		Girl's Restroom right handwashing sink		
		Result:	<1.0	ppb
		Date Sampled:	3/27/2024	By: JH
Recommended Action:

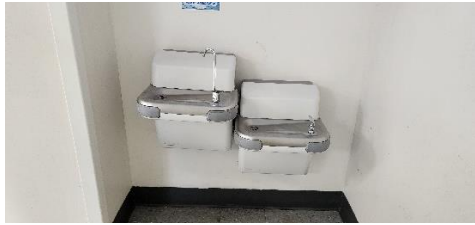
ID:	294-SHS-212	Location:	3rd Floor by Elevator	
Photo:

Manufacturer:	Halsey Taylor	
		Description:		
		Left Drinking fountain bottle filler		
		Result:	3.5	ppb
		Date Sampled:	3/27/2024	By: JH
Recommended Action:

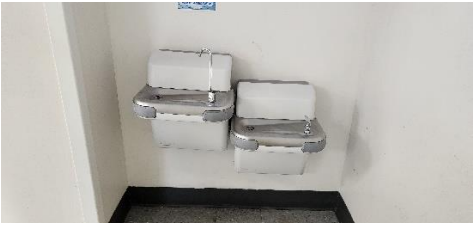
ID:	294-SHS-213	Location:	3rd Floor by Elevator	
Photo:

Manufacturer:	Halsey Taylor	
		Description:		
		Right Drinking fountain bubbler		
		Result:	<1.0	ppb
		Date Sampled:	3/27/2024	By: JH
Recommended Action:
