OCCU-TEC
Protecting People, Places and Performance

RE: Drinking Water Sampling – Antonia Elementary School
3901 Old State Road M, Imperial, MO 63052
Project Number: 923294

Drinking Water Assessment
Antonia Elementary School
Fox C-6 School District

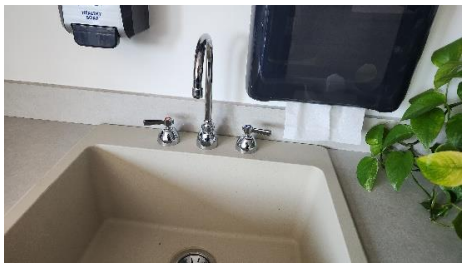
ID:	294-AES-07	Location:	Room 30		
Photo:

Manufacturer:	Chicago Faucet Company		
		Description:			
		Sink			
		Result:	<1.0	ppb	
		Date Sampled:	3/27/2024	By:	JEA
Recommended Action:

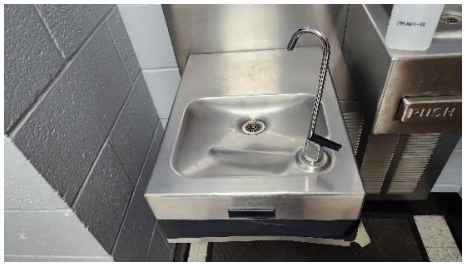
ID:	294-AES-21	Location:	Hall Near 24/26		
Photo:

Manufacturer:	Unknown		
		Description:			
		Drinking Fountain Bottle Filler - Left			
		Result:	<1.0	ppb	
		Date Sampled:	3/27/2024	By:	JEA
Recommended Action:

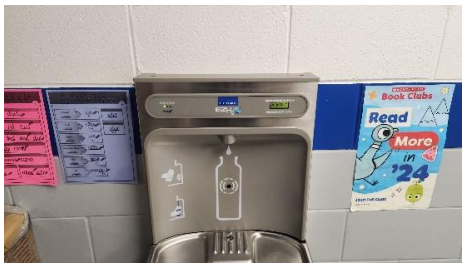
ID:	294-AES-28	Location:	Hall Near Room 16		
Photo:

Manufacturer:	Elkay		
		Description:			
		Drinking Fountain Bottle Filler			
		Result:	<1.0	ppb	
		Date Sampled:	3/27/2024	By:	JEA
Recommended Action:
