RE: Drinking Water Sampling – Hodge Elementary School
2499 Prairie Hollow Road, Imperial, MO 63052
Project Number: 923294

Drinking Water Assessment
Hodge Elementary School
Fox C-6 School District

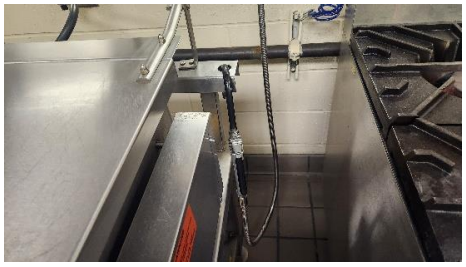
ID:	294-HES-09	Location:	Kitchen Food Prep Area	
Photo:

Manufacturer:	Fisher	
		Description:		
		Pot Filler		
		Result:	<1.0	ppb
		Date Sampled:	3/28/2024	By: JEA
Recommended Action:
