RE: Drinking Water Sampling – Meramac Heights Elementary
1340 W. Outer 21 Road, Arnold, MO 63010
Project Number: 923294

Drinking Water Assessment
Meremac Heights Elementary School
Fox C-6 School District

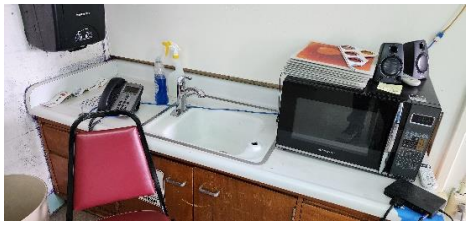
ID:	294-MHE-24	Location:	Room 101	
Photo:

Manufacturer:	Moen	
		Description:		
		Sink		
		Result:	4.7	ppb
		Date Sampled:	3/26/2024	By: JH
Recommended Action:

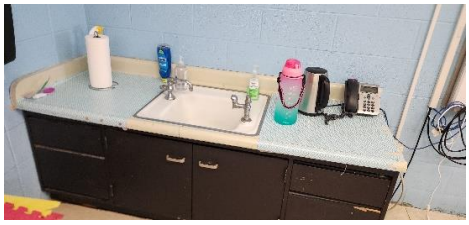
ID:	294-MHE-25	Location:	Room 102	
Photo:

Manufacturer:	Unknown	
		Description:		
		Drinking Fountain bubbler		
		Result:	3.5	ppb
		Date Sampled:	3/26/2024	By: JH
Recommended Action:

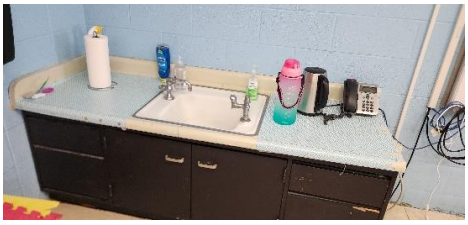
ID:	294-MHE-26	Location:	Room 102	
Photo:

Manufacturer:	Unknown	
		Description:		
		Sink		
		Result:	1.9	ppb
		Date Sampled:	3/26/2024	By: JH
Recommended Action:
