RE: Drinking Water Sampling – Seckman Elementary School
2824 Seckman Rd, Imperial, MO 63052
Project Number: 923294

Drinking Water Assessment
Seckman Elementary School
Fox C-6 School District

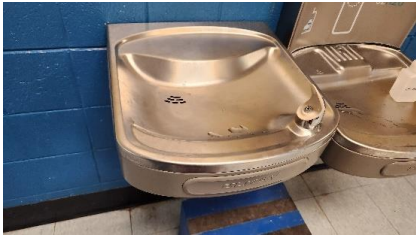
ID:	294-SME-01	Location:	Front Lobby Hall	
Photo:

Manufacturer:	Elkay	
		Description:		
		Drinking Fountain Bubbler - Left		
		Result:	<1.0	ppb
		Date Sampled:	3/27/2024	By: JEA
Recommended Action:

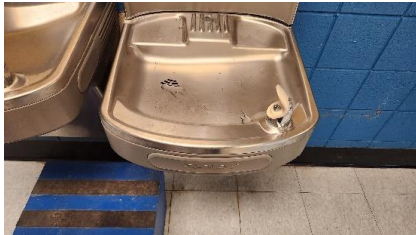
ID:	294-SME-02	Location:	Front Lobby Hall	
Photo:

Manufacturer:	Elkay	
		Description:		
		Drinking Fountain Bubbler - Right		
		Result:	<1.0	ppb
		Date Sampled:	3/27/2024	By: JEA
Recommended Action:

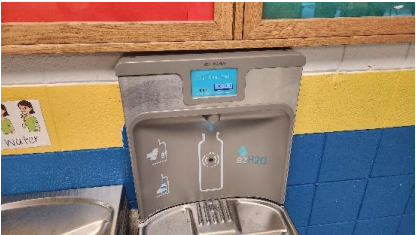
ID:	294-SME-03	Location:	Front Lobby Hall	
Photo:

Manufacturer:	Elkay	
		Description:		
		Drinking Fountain Bottle Filler - Right		
		Result:	<1.0	ppb
		Date Sampled:	3/27/2024	By: JEA
Recommended Action:

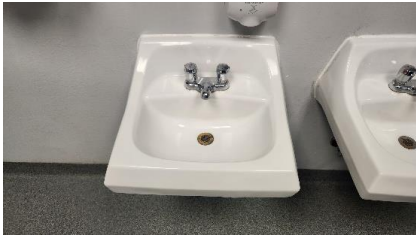
ID:	294-SME-04	Location:	Front Lobby Hall Boys RR	
Photo:

Manufacturer:	Chicago Faucet Company	
		Description:		
		Handwashing Sink - Left		
		Result:	<1.0	ppb
		Date Sampled:	3/27/2024	By: JEA
Recommended Action:

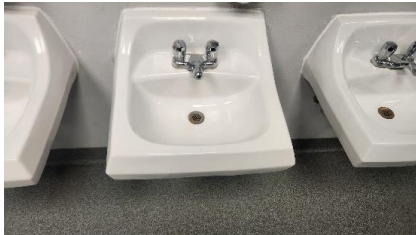
ID:	294-SME-05	Location:	Front Lobby Hall Boys RR	
Photo:

Manufacturer:	Chicago Faucet Company	
		Description:		
		Handwashing Sink - Middle		
		Result:	1.2	ppb
		Date Sampled:	3/27/2024	By: JEA
Recommended Action:

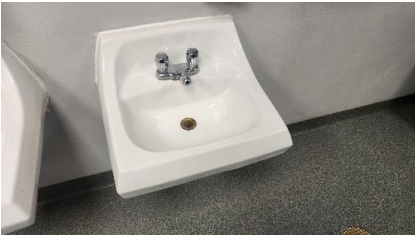
ID:	294-SME-06	Location:	Front Lobby Hall Boys RR	
Photo:

Manufacturer:	Chicago Faucet Company	
		Description:		
		Handwashing Sink - Right		
		Result:	<1.0	ppb
		Date Sampled:	3/27/2024	By: JEA
Recommended Action:

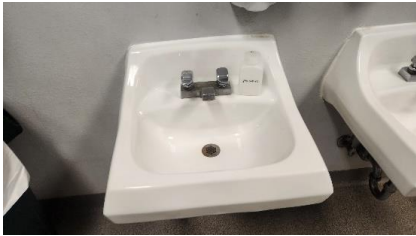
ID:	294-SME-07	Location:	Front Lobby Hall Girls RR	
Photo:

Manufacturer:	Chicago Faucet Company	
		Description:		
		Handwashing Sink - Left		
		Result:	<1.0	ppb
		Date Sampled:	3/27/2024	By: JEA
Recommended Action:

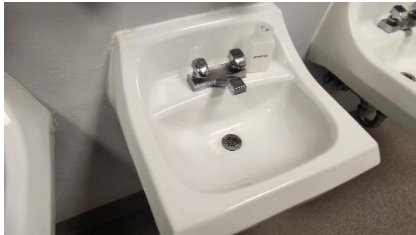
ID:	294-SME-08	Location:	Front Lobby Hall Girls RR	
Photo:

Manufacturer:	Chicago Faucet Company	
		Description:		
		Handwashing Sink - Middle		
		Result:	<1.0	ppb
		Date Sampled:	3/27/2024	By: JEA
Recommended Action:

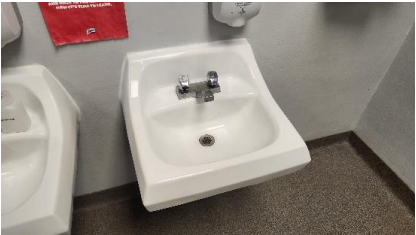
ID:	294-SME-09	Location:	Front Lobby Hall Girls RR	
Photo:

Manufacturer:	Chicago Faucet Company	
		Description:		
		Handwashing Sink - Right		
		Result:	<1.0	ppb
		Date Sampled:	3/27/2024	By: JEA
Recommended Action:

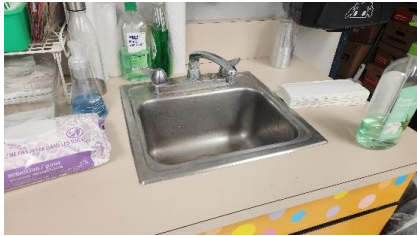
ID:	294-SME-10	Location:	C Pod lobby	
Photo:

Manufacturer:	Chicago Faucet Company	
		Description:		
		Sink		
		Result:	2	ppb
		Date Sampled:	3/27/2024	By: JEA
Recommended Action:

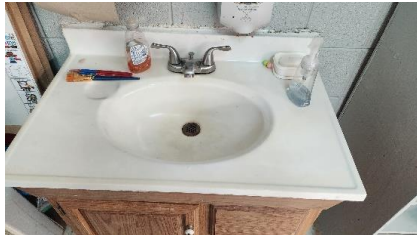
ID:	294-SME-11	Location:	Room near D Pod Door/Pre K	
Photo:

Manufacturer:	Project Source	
		Description:		
		Sink		
		Result:	<1.0	ppb
		Date Sampled:	3/27/2024	By: JEA
Recommended Action:

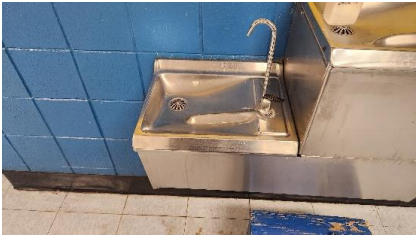
ID:	294-SME-12	Location:	Hall to D pod	
Photo:

Manufacturer:	Halsey Taylor	
		Description:		
		Drinking Fountain Bottle Filler Left		
		Result:	<1.0	ppb
		Date Sampled:	3/27/2024	By: JEA
Recommended Action:

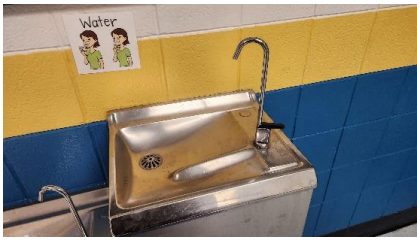
ID:	294-SME-13	Location:	Hall to D pod	
Photo:

Manufacturer:	Halsey Taylor	
		Description:		
		Drinking Fountain Bottle Filler Right		
		Result:	<1.0	ppb
		Date Sampled:	3/27/2024	By: JEA
Recommended Action:

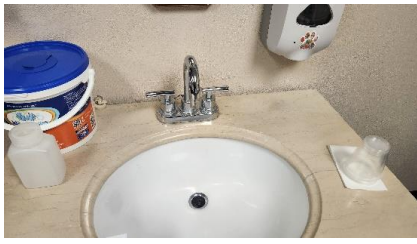
ID:	294-SME-14	Location:	D Pod Office	
Photo:

Manufacturer:	Pegasus	
		Description:		
		Sink		
		Result:	4.3	ppb
		Date Sampled:	3/27/2024	By: JEA
Recommended Action:

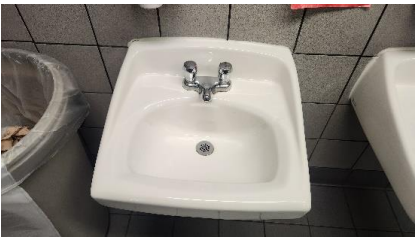
ID:	294-SME-15	Location:	E Pod Hall Girls RR	
Photo:

Manufacturer:	Chicago Faucet Company	
		Description:		
		3 Stage Sink Left Side		
		Result:	<1.0	ppb
		Date Sampled:	3/27/2024	By: JEA
Recommended Action:

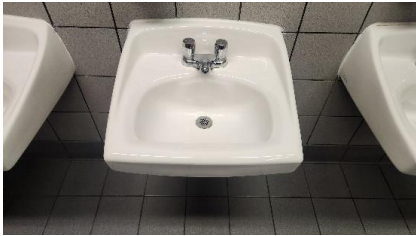
ID:	294-SME-16	Location:	E Pod Hall Girls RR	
Photo:

Manufacturer:	Chicago Faucet Company	
		Description:		
		3 Stage Sink Middle Side		
		Result:	<1.0	ppb
		Date Sampled:	3/27/2024	By: JEA
Recommended Action:

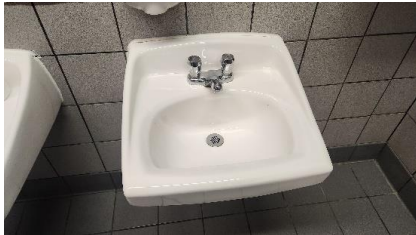
ID:	294-SME-17	Location:	E Pod Hall Girls RR	
Photo:

Manufacturer:	Chicago Faucet Company	
		Description:		
		3 Stage Sink Right Side		
		Result:	<1.0	ppb
		Date Sampled:	3/27/2024	By: JEA
Recommended Action:

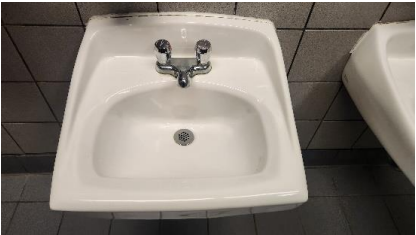
ID:	294-SME-18	Location:	E Pod Hall Boys RR	
Photo:

Manufacturer:	Chicago Faucet Company	
		Description:		
		3 Stage Sink Left Side		
		Result:	<1.0	ppb
		Date Sampled:	3/27/2024	By: JEA
Recommended Action:

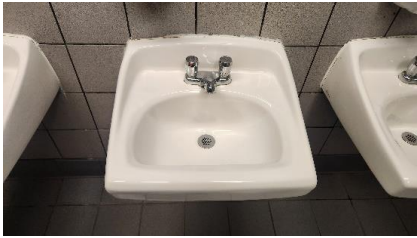
ID:	294-SME-19	Location:	E Pod Hall Boys RR	
Photo:

Manufacturer:	Chicago Faucet Company	
		Description:		
		3 Stage Sink Middle Side		
		Result:	<1.0	ppb
		Date Sampled:	3/27/2024	By: JEA
Recommended Action:

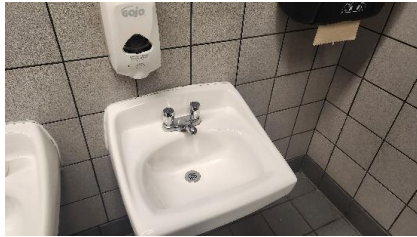
ID:	294-SME-20	Location:	E Pod Hall Boys RR	
Photo:

Manufacturer:	Chicago Faucet Company	
		Description:		
		3 Stage Sink Right Side		
		Result:	<1.0	ppb
		Date Sampled:	3/27/2024	By: JEA
Recommended Action:

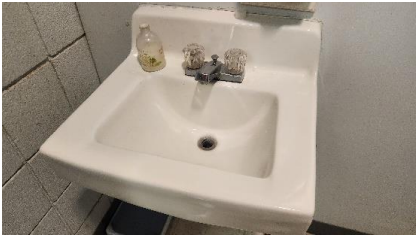
ID:	294-SME-21	Location:	Staff RR near R3	
Photo:

Manufacturer:	Unknown	
		Description:		
		Sink		
		Result:	<1.0	ppb
		Date Sampled:	3/27/2024	By: JEA
Recommended Action:

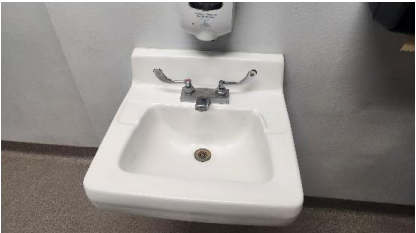
ID:	294-SME-24	Location:	Hall Near E6 Girls RR		
Photo:

Manufacturer:	Chicago Faucet Company		
		Description:			
		Handwashing Sink Left			
		Result:	<1.0	ppb	
		Date Sampled:	3/27/2024	By:	JEA
Recommended Action:

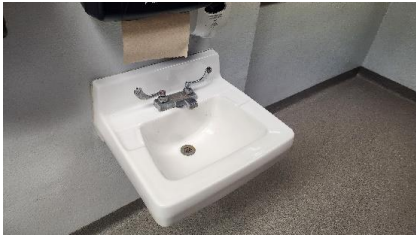
ID:	294-SME-25	Location:	Hall Near E6 Girls RR	
Photo:

Manufacturer:	Chicago Faucet Company	
		Description:		
		Handwashing Sink Right		
		Result:	<1.0	ppb
		Date Sampled:	3/27/2024	By: JEA
Recommended Action:

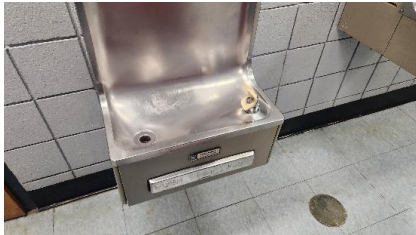
ID:	294-SME-26	Location:	Hall Near E6	
Photo:

Manufacturer:	Elkay	
		Description:		
		Drinking Fountain Bubbler - Left		
		Result:	<1.0	ppb
		Date Sampled:	3/27/2024	By: JEA
Recommended Action:

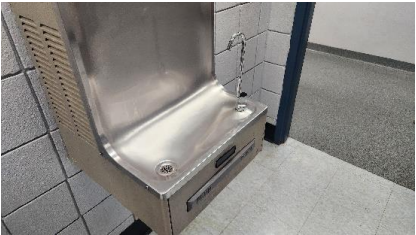
ID:	294-SME-27	Location:	Hall Near E6	
Photo:

Manufacturer:	Elkay	
		Description:		
		Drinking Fountain Bubbler - Right		
		Result:	<1.0	ppb
		Date Sampled:	3/27/2024	By: JEA
Recommended Action:

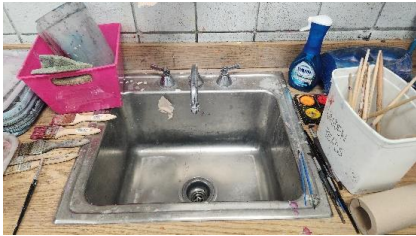
ID:	294-SME-28	Location:	Art Room	
Photo:

Manufacturer:	Chicago Faucet Company	
		Description:		
		Handwashing Sink left		
		Result:	<1.0	ppb
		Date Sampled:	3/27/2024	By: JEA
Recommended Action:

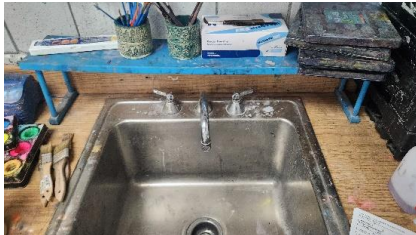
ID:	294-SME-29	Location:	Art Room	
Photo:

Manufacturer:	Chicago Faucet Company	
		Description:		
		Handwashing Sink right		
		Result:	<1.0	ppb
		Date Sampled:	3/27/2024	By: JEA
Recommended Action:

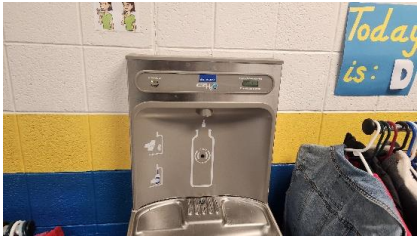
ID:	294-SME-31	Location:	Hall near Café	
Photo:

Manufacturer:	Elkay	
		Description:		
		Drinking Fountain Bottle Filler		
		Result:	<1.0	ppb
		Date Sampled:	3/27/2024	By: JEA
Recommended Action:

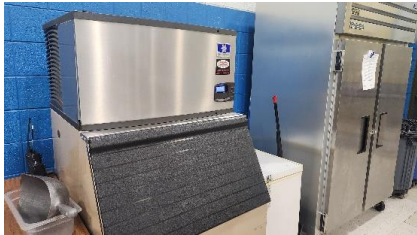
ID:	294-SME-32	Location:	Cafeteria	
Photo:

Manufacturer:	Manitowoc	
		Description:		
		Ice Machine		
		Result:	<1.0	ppb
		Date Sampled:	3/27/2024	By: JEA
Recommended Action:

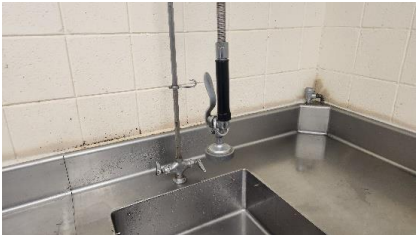
ID:	294-SME-33	Location:	Kitchen - Dish Room	
Photo:

Manufacturer:	Encore	
		Description:		
		Dish Sprayer		
		Result:	<1.0	ppb
		Date Sampled:	3/27/2024	By: JEA
Recommended Action:

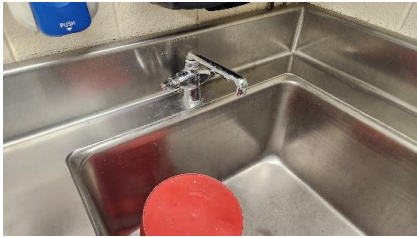
ID:	294-SME-34	Location:	Kitchen - Dish Room	
Photo:

Manufacturer:	Chicago Faucet Company	
		Description:		
		Sink		
		Result:	3.2	ppb
		Date Sampled:	3/27/2024	By: JEA
Recommended Action:

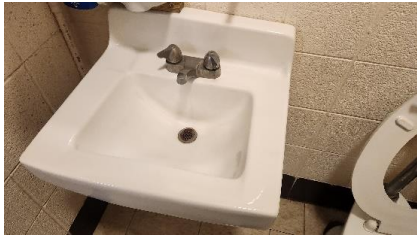
ID:	294-SME-35	Location:	Kitchen Restroom	
Photo:

Manufacturer:	Chicago Faucet Company	
		Description:		
		Sink		
		Result:	<1.0	ppb
		Date Sampled:	3/27/2024	By: JEA
Recommended Action:

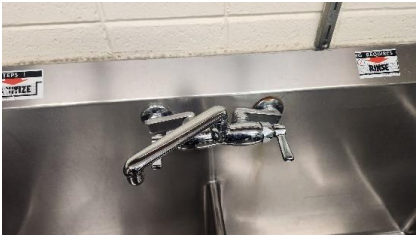
ID:	294-SME-36	Location:	Kitchen Food Prep Area	
Photo:

Sample ID	Location	Type	Result (ug/L)
294-SME-36	Kitchen – Food Prep Area	3 Stage Sink – Sanitize	10.8
294-SME-39	Kitchen – Food Prep Area	Pot Filler	14.3
294-SME-46	A Pod Center Room	Sink	5.8

Manufacturer:	Chicago Faucet Company	
		Description:		
		3 Stage Sink Sanitize Side		
		Result:	10.8	ppb
		Date Sampled:	3/27/2024	By: JEA
Recommended Action:		Replace Fixture and resample

In accordance with the requirements set forth in Missouri Bill 681/662, fixtures exhibiting lead concentrations above 5 ppb must be remediated by replacement of lead-containing pipes, solder, fittings or fixtures with lead-free components, or the school shall install filtration at each point where water enters the building until such time as the source can be remediated. If installing a filter is not feasible, the school shall provide purified water at each outlet inventoried.

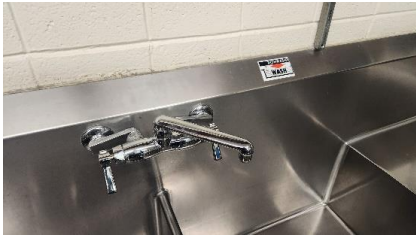
ID:	294-SME-37	Location:	Kitchen Food Prep Area	
Photo:

Manufacturer:	Chicago Faucet Company	
		Description:		
		3 Stage Sink Wash Side		
		Result:	<1.0	ppb
		Date Sampled:	3/27/2024	By: JEA
Recommended Action:

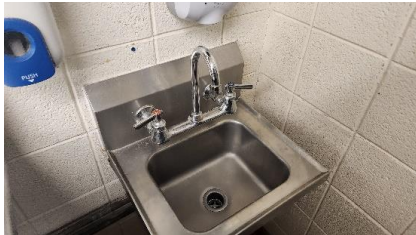
ID:	294-SME-38	Location:	Kitchen Food Prep Area	
Photo:

Manufacturer:	Chicago Faucet Company	
		Description:		
		Handwashing Sink		
		Result:	1.1	ppb
		Date Sampled:	3/27/2024	By: JEA
Recommended Action:

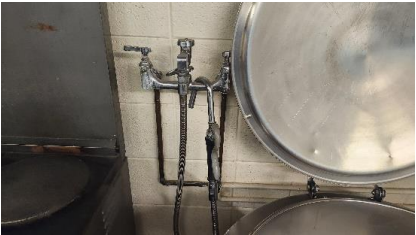
ID:	294-SME-39	Location:	Kitchen Food Prep Area	
Photo:

Manufacturer:	Unknown	
		Description:		
		Pot Filler		
		Result:	14.3	ppb
		Date Sampled:	3/27/2024	By: JEA
Recommended Action:		Replace Fixture and resample

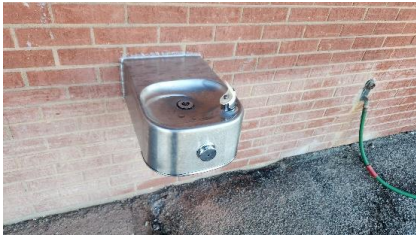
ID:	294-SME-40	Location:	Exterior Playground	
Photo:

Manufacturer:	Elkay	
		Description:		
		Drinking Fountain bubbler		
		Result:	1.1	ppb
		Date Sampled:	3/27/2024	By: JEA
Recommended Action:

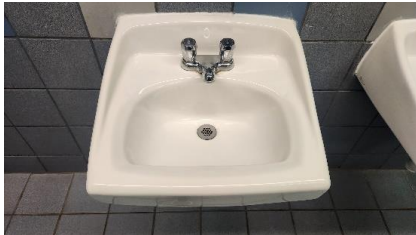
ID:	294-SME-41	Location:	Café hall Boys RR	
Photo:

Manufacturer:	Chicago Faucet Company	
		Description:		
		Handwashing Sink - Left		
		Result:	<1.0	ppb
		Date Sampled:	3/27/2024	By: JEA
Recommended Action:

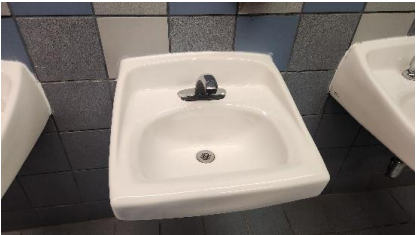
ID:	294-SME-42	Location:	Café hall Boys RR	
Photo:

Manufacturer:	Sloan	
		Description:		
		Handwashing Sink - Middle		
		Result:	<1.0	ppb
		Date Sampled:	3/27/2024	By: JEA
Recommended Action:

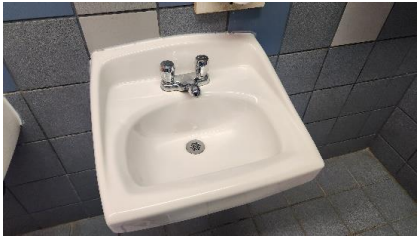
ID:	294-SME-43	Location:	Café hall Boys RR	
Photo:

Manufacturer:	Chicago Faucet Company	
		Description:		
		Handwashing Sink - Right		
		Result:	<1.0	ppb
		Date Sampled:	3/27/2024	By: JEA
Recommended Action:

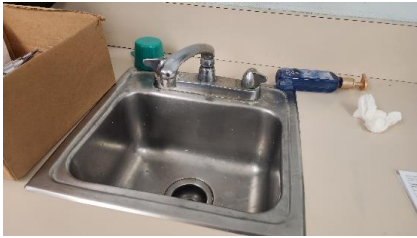
ID:	294-SME-46	Location:	A Pod Center Room	
Photo:

Manufacturer:	Chicago Faucet Company	
		Description:		
		Sink		
		Result:	5.8	ppb
		Date Sampled:	3/27/2024	By: JEA
Recommended Action:		Replace Fixture and resample

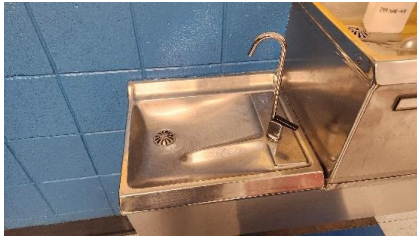
ID:	294-SME-47	Location:	Music Room Hall	
Photo:

Manufacturer:	Halsey Taylor	
		Description:		
		Drinking Fountain Bottle Filler Left Side		
		Result:	<1.0	ppb
		Date Sampled:	3/27/2024	By: JEA
Recommended Action:

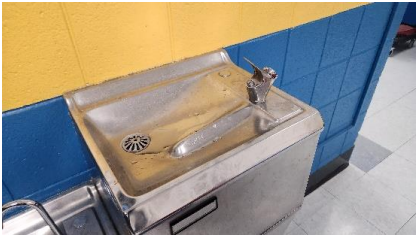
ID:	294-SME-48	Location:	Music Room Hall	
Photo:

Manufacturer:	Halsey Taylor	
		Description:		
		Drinking Fountain Bubbler - Right		
		Result:	<1.0	ppb
		Date Sampled:	3/27/2024	By: JEA
Recommended Action:

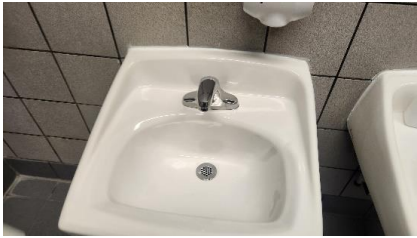
ID:	294-SME-49	Location:	B Pod Girls Restroom	
Photo:

Manufacturer:	Equip	
		Description:		
		Handwashing - Left		
		Result:	2	ppb
		Date Sampled:	3/27/2024	By: JEA
Recommended Action:

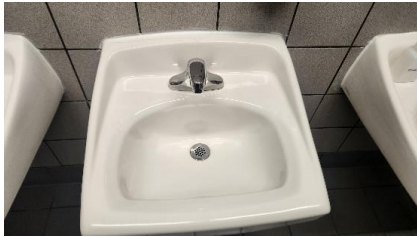
ID:	294-SME-50	Location:	B Pod Girls Restroom	
Photo:

Manufacturer:	Equip	
		Description:		
		Handwashing - Middle		
		Result:	1.1	ppb
		Date Sampled:	3/27/2024	By: JEA
Recommended Action:

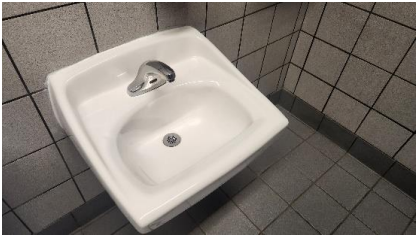
ID:	294-SME-51	Location:	B Pod Girls Restroom	
Photo:

Manufacturer:	Equip	
		Description:		
		Handwashing - Right		
		Result:	<1.0	ppb
		Date Sampled:	3/27/2024	By: JEA
Recommended Action:

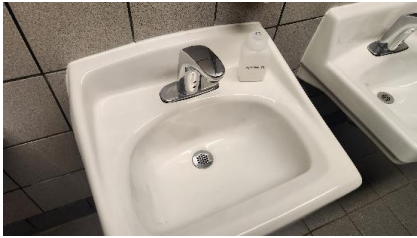
ID:	294-SME-52	Location:	B Pod Boys Restroom	
Photo:

Manufacturer:	Equip	
		Description:		
		Handwashing - Left		
		Result:	<1.0	ppb
		Date Sampled:	3/27/2024	By: JEA
Recommended Action:

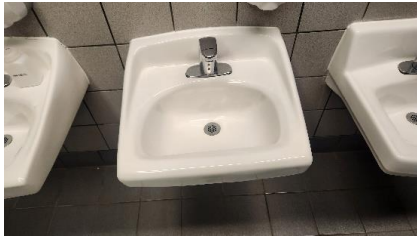
ID:	294-SME-53	Location:	B Pod Boys Restroom	
Photo:

Manufacturer:	Equip	
		Description:		
		Handwashing - Middle		
		Result:	<1.0	ppb
		Date Sampled:	3/27/2024	By: JEA
Recommended Action:

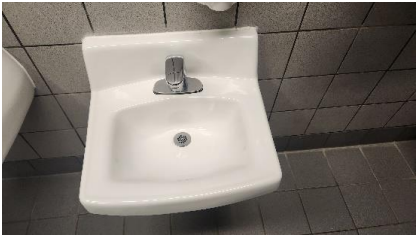
ID:	294-SME-54	Location:	B Pod Boys Restroom	
Photo:

Manufacturer:	Equip	
		Description:		
		Handwashing - Right		
		Result:	<1.0	ppb
		Date Sampled:	3/27/2024	By: JEA
Recommended Action:

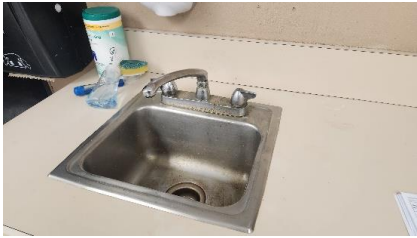
ID:	294-SME-55	Location:	B Pod Center		
Photo:

Manufacturer:	Chicago Faucet Company		
		Description:			
		Sink			
		Result:	2.4	ppb	
		Date Sampled:	3/27/2024	By:	JEA
Recommended Action:
